# LYNTONVALE AVENUE GATLEY

Snagging Report

Thursday, 9 January 2020

Prepared For Mr N Jones

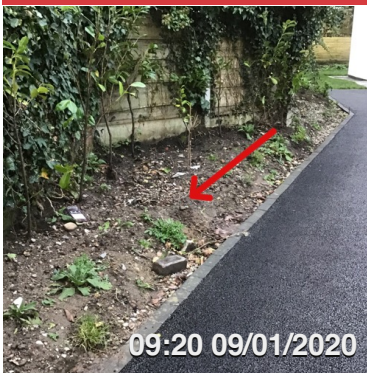
## **LOCATION 2 FRONT DRIVE**

The left hand garden area needs the rubble removing and the soil lowering to the drive edging.

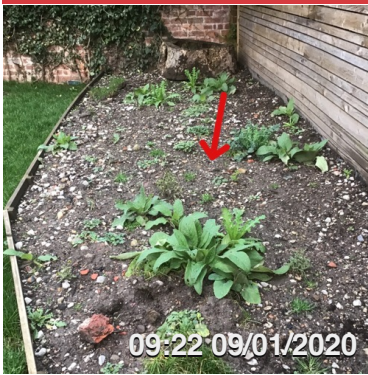
## **LOCATION 3 FRONT DRIVE**

The soil needs lowering on the left hand side and the hardcore removing.

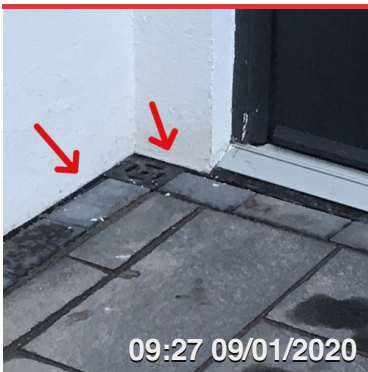
#### **LOCATION 6 FRONT ELEVATION**

The left hand corner render bead needs filling above the gully.

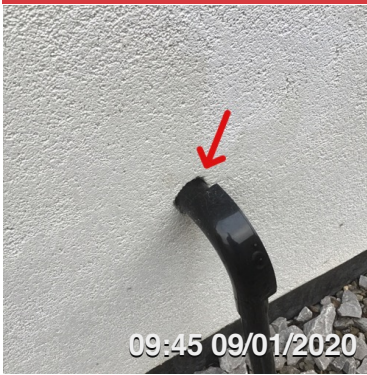
## LOCATION 19 RIGHT HAND ELEVATION

The soil pipe needs sealing better.

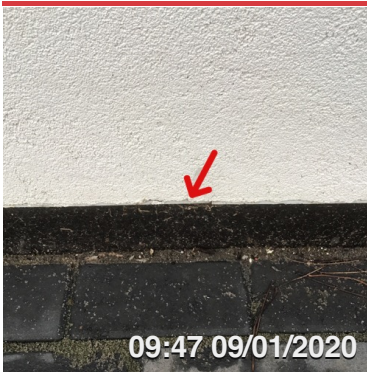
### **LOCATION 20 RIGHT HAND ELEVATION**

The conduit needs sealing.

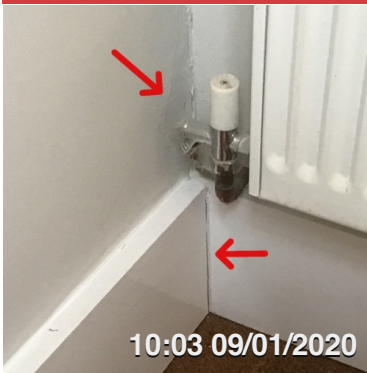
### LOCATION 31 HALL

The left hand corner needs caulking to the skirting boards.

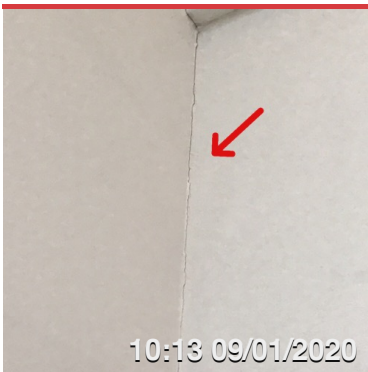
### **LOCATION 38 HALL**

The wall needs filling to the right of the lounge door.

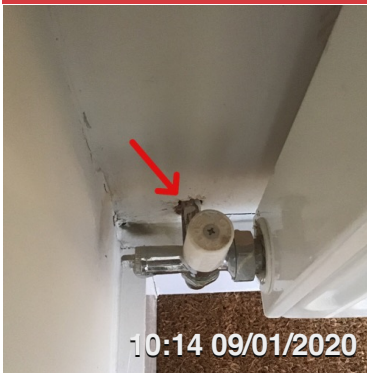
### **LOCATION 39 HALL**

The corner needs caulking above the radiator.

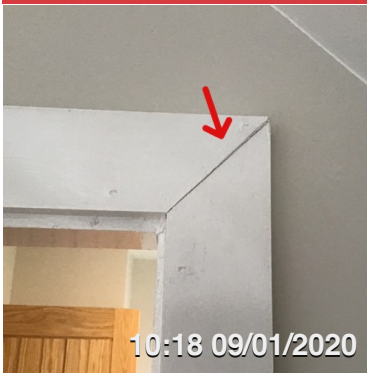
### **LOCATION 43 HALL**

The study casing needs sanding and the architraves need filling

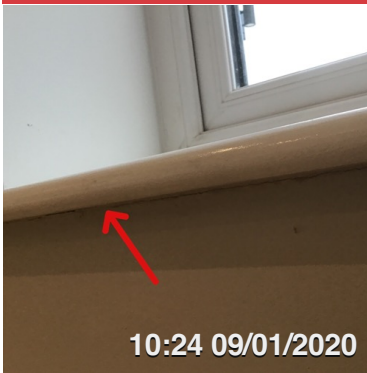
#### **LOCATION 47 LOUNGE**

The skirting board has a deflection of over 20mm and needs rectifying on the left hand wall below the window.

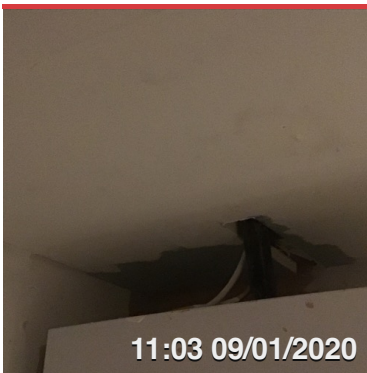
### **LOCATION 77 CYLINDER CUPBOARD**

The pipe needs fire sealing.

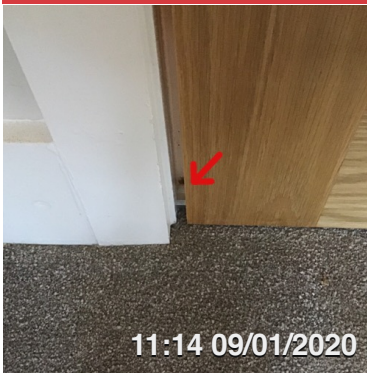
### **LOCATION 87 STUDY**

The kitchen door casing needs sanding and filling..

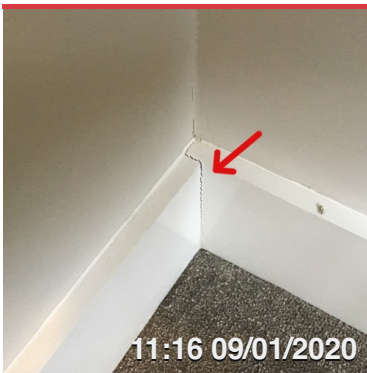
### LOCATION 89 STUDY

The architrave is split and needs filling to the kitchen door..

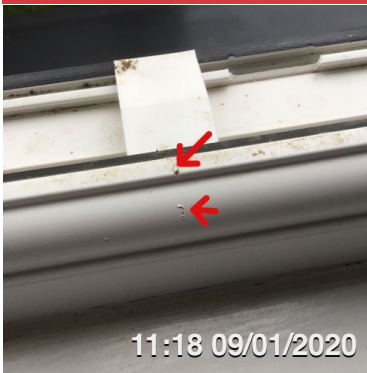
### LOCATION 91 STUDY

The window board needs caulking and repainting where it is scratched.

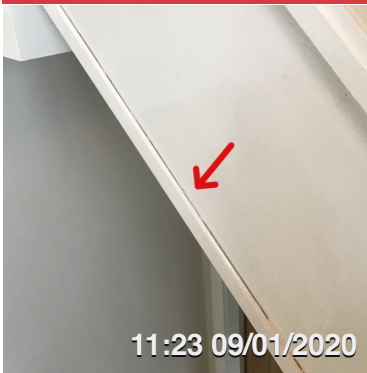
### LOCATION 95 STAIRS TO FIRST FLOOR

The quadrant over the right hand string needs caulking.

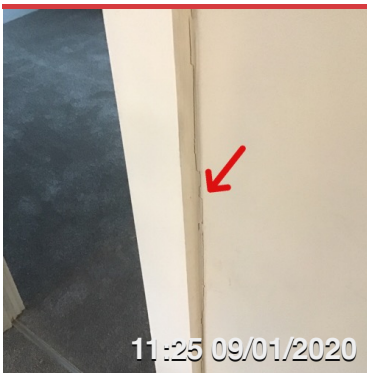
### **LOCATION 97 LANDING**

The half newel needs caulking.

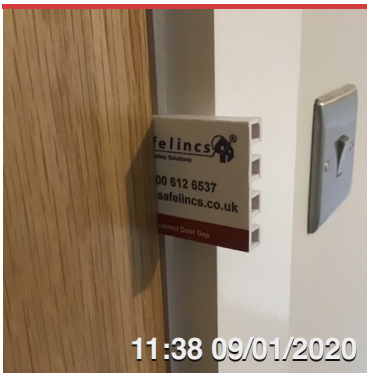
#### **LOCATION 109 BEDROOM 4**

The casing needs filling.

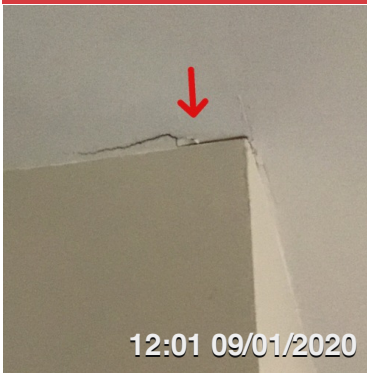
### **LOCATION 131 BEDROOM 1**

The wall needs filling above the en suite door.
