I Lively
Lively Professional Services Ltd

**14 ATHERTON DRIVE, PRESCOT,
MERSEYSIDE, L35 7AG**

Monday, 25 March 2019

94 Issues Identified

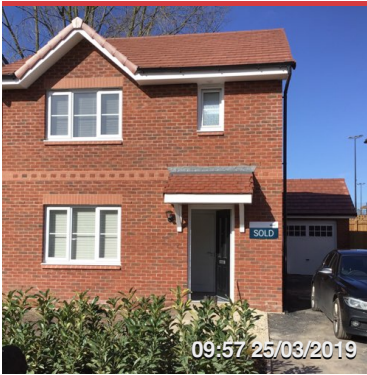
LOCATION 1 14 ATHERTON DRIVE

Assigned To Plot Identification.

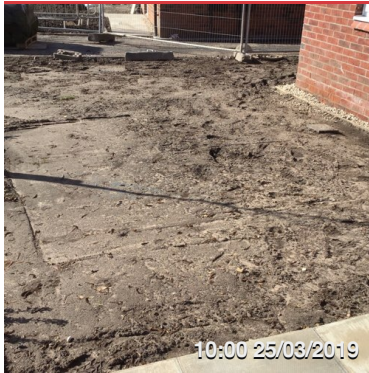
LOCATION 5 FRONT ELEVATION

Turf required to the front garden. This was completed during the inspection, please ensure it is watered well.

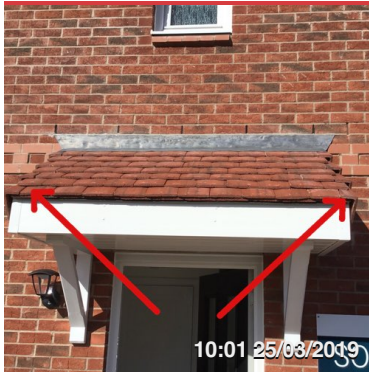
LOCATION 6 FRONT ELEVATION

The clay verges need a bottom fixing.

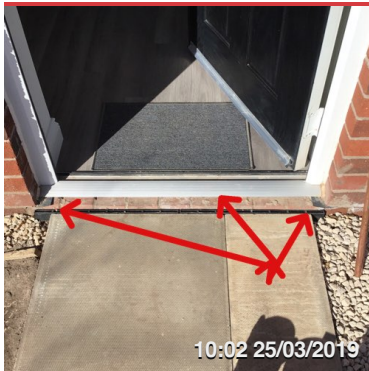
LOCATION 7 FRONT ELEVATION

The front door threshold needs pointing and the dpc removing, the threshold also needs the sill sealing to stop water penetration.

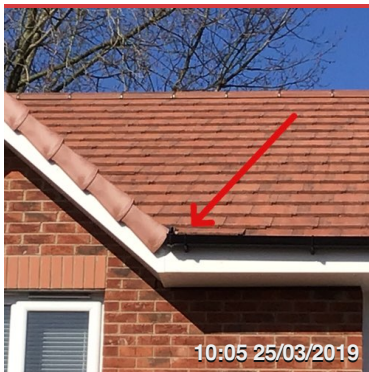
LOCATION 8 FRONT ELEVATION

The bottom tile is kicking on the valley.

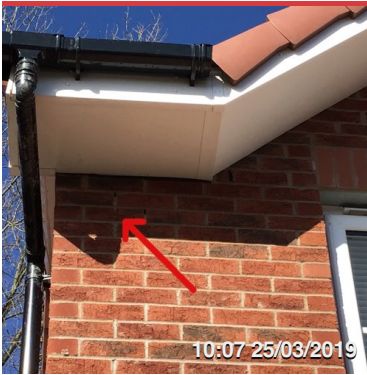
LOCATION 9 FRONT ELEVATION

Two perps need pointing.

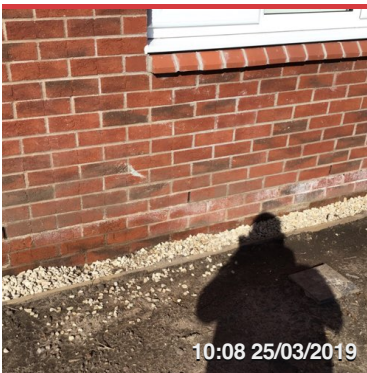
LOCATION 11 FRONT ELEVATION

Weep holes should be every 450mm unless stated otherwise.

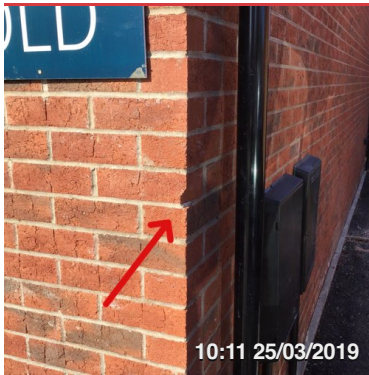
LOCATION 13 RIGHT HAND ELEVATION

There is a damaged brick on the right hand corner.

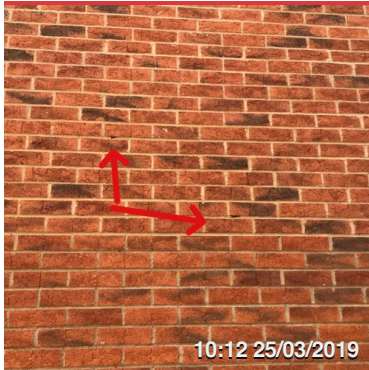
LOCATION 14 RIGHT HAND ELEVATION

Small area of brickwork requires pointing.

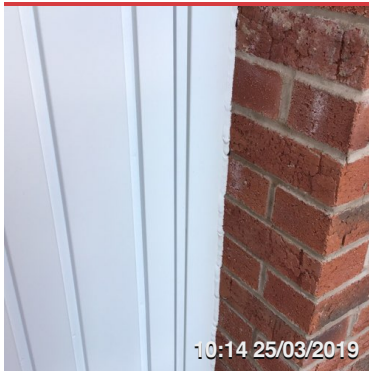
LOCATION 15 GARAGE

The mastic application is very poor and needs reapplying.

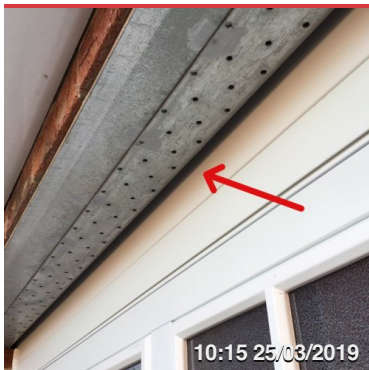
LOCATION 16 GARAGE

The garage door head needs finishing, there is a piece of fascia on the internal side of the garage lintel.

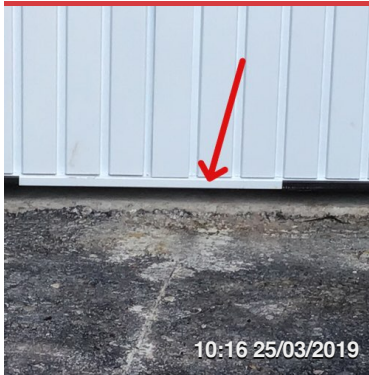
LOCATION 17 GARAGE

The gap below the garage door is excessive.

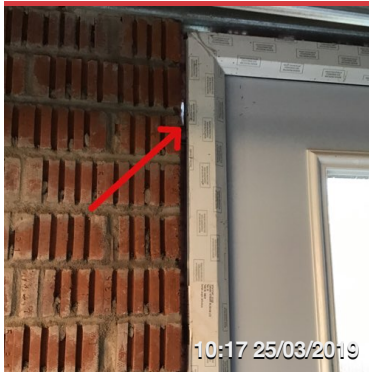
LOCATION 18 GARAGE

The finish around the internal garage door needs attention, poor finish.

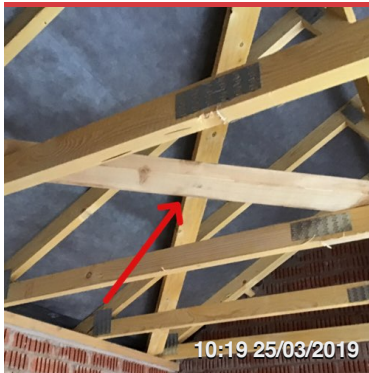
LOCATION 19 GARAGE

Loose timber needs removing from the roof space.

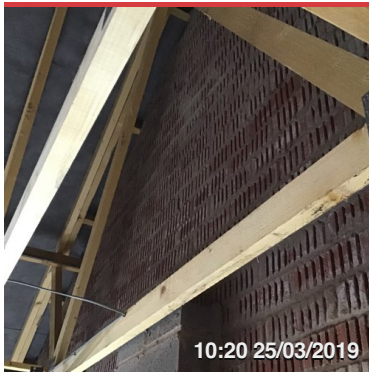
LOCATION 20 GARAGE

The block pillars need extending up the pike to give restraint against win loading. (NHBC 10.1.5)

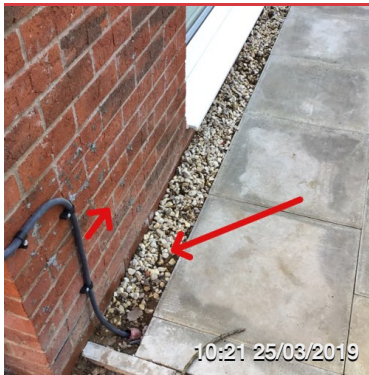
LOCATION 21 REAR ELEVATION

The limestone chippings need finishing and the debris removing.
The electric feed to the garage needs moving for the gate post to fit.

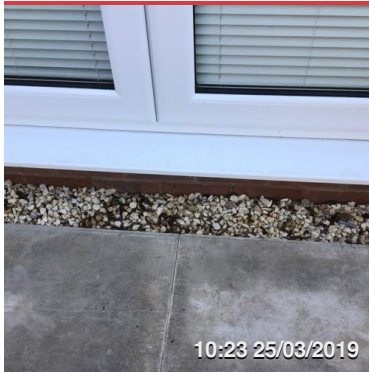
LOCATION 22 REAR ELEVATION

The underside of the patio needs sealing.

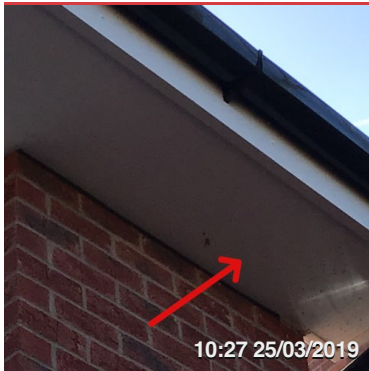
LOCATION 23 REAR ELEVATION

The soffit needs cleaning.

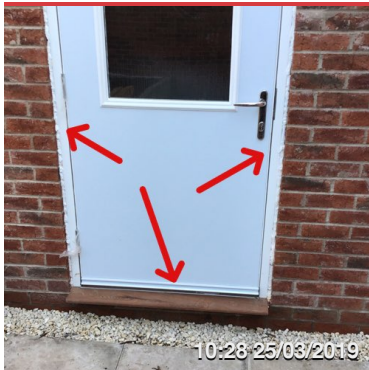
LOCATION 24 GARAGE

The frame needs sealing and the sill painting.

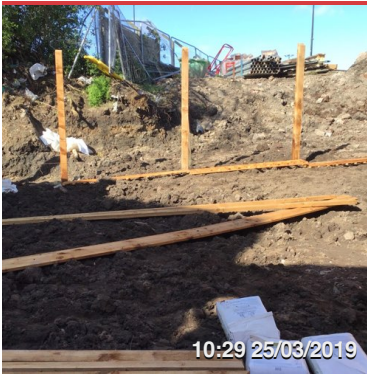
LOCATION 25 REAR ELEVATION

The rear fence needs finishing and the garden landscaping. This was being done during the inspection. Please ensure the turf is watered well.

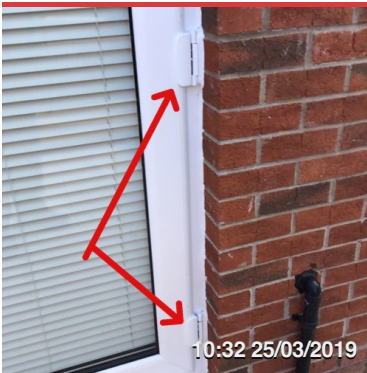
LOCATION 27 REAR ELEVATION

The right hand patio door bottom and middle hinges are damaged.

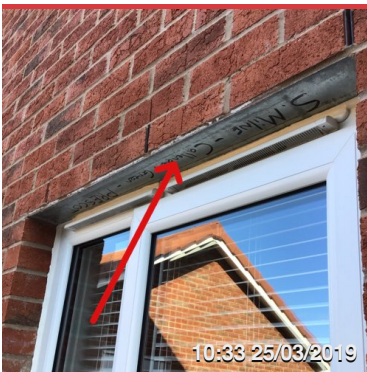
LOCATION 28 REAR ELEVATION

The writing needs removing from the kitchen lintel.

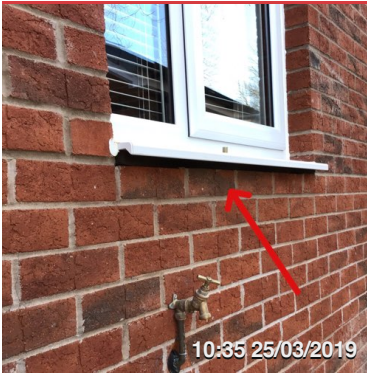
LOCATION 29 EXTERNAL

Once the house has settled ensure the underside of the frames are sealed.

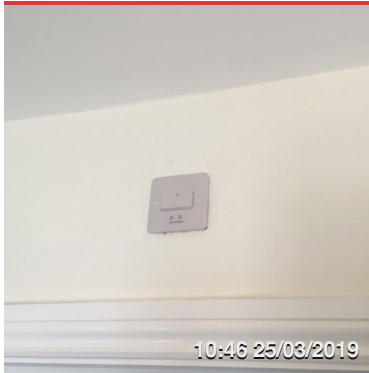
LOCATION 33 HALL

Touch up around the fan isolator for the downstairs cloaks.

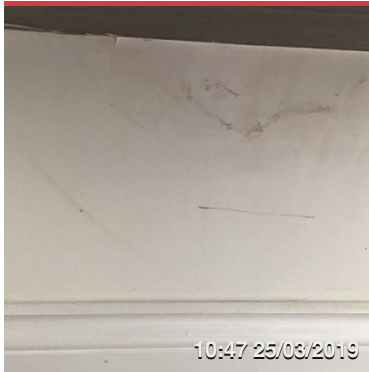
LOCATION 34 DOWN STAIRS CLOAKS

Re paint under the sink unit

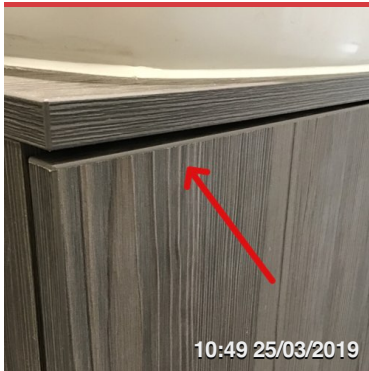
LOCATION 35 DOWN STAIRS CLOAKS

Align the sink base unit door.

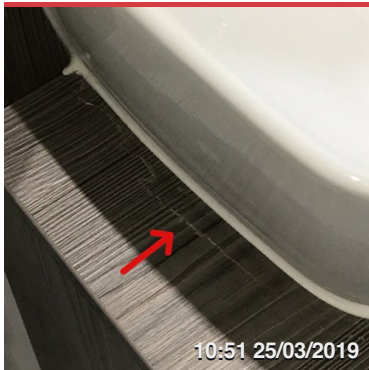
LOCATION 36 DOWN STAIRS CLOAKS

Clean the silicone off the unit and the sink is running out of line with the mirror on the right hand side.

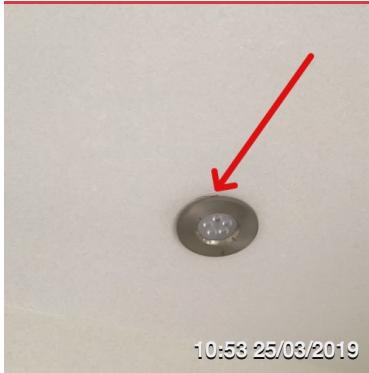
LOCATION 37 DOWN STAIRS CLOAKS

Minor touch up to the front downlight.

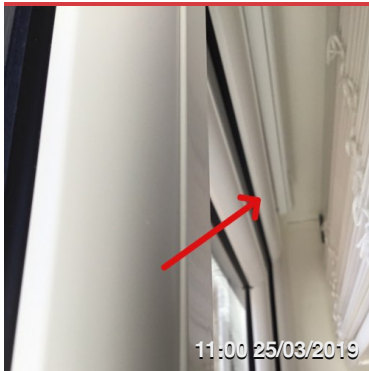
LOCATION 39 LOUNGE

The right hand trickle vent needs tightening back to the frame.

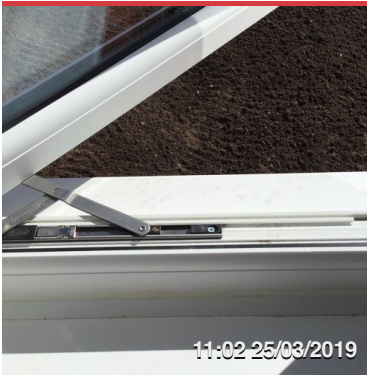
LOCATION 41 LOUNGE

The left hand window frame is damaged as the right hand one.

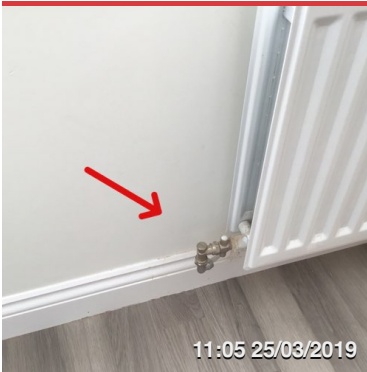
LOCATION 42 LOUNGE

The wall needs filling to the left of the radiator.

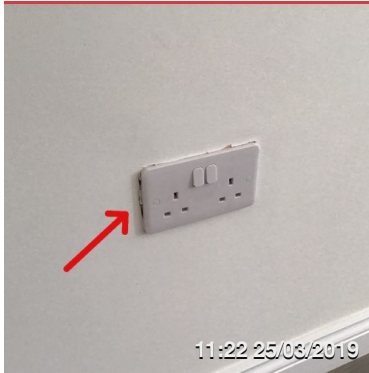
LOCATION 45 LOUNGE

Fill and touch up around the socket.

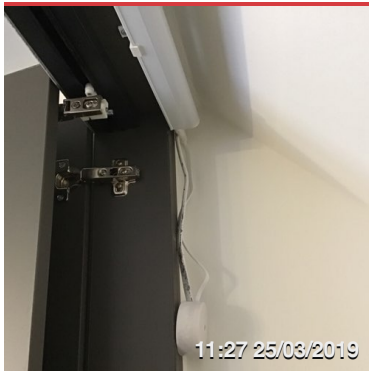
LOCATION 47 KITCHEN

The cables in the understairs cupboard needs shortening.

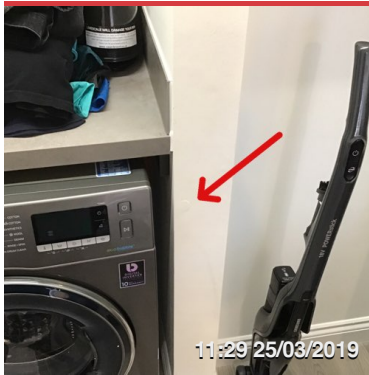
LOCATION 49 KITCHEN

The nib in the utility area needs attention poor plastering.

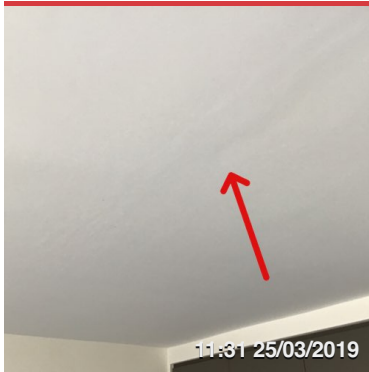
LOCATION 50 KITCHEN

The kitchen ceiling is showing board joints and trowel marks.

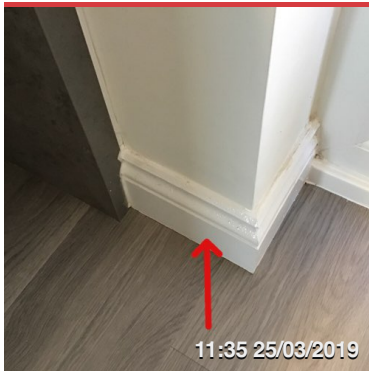
LOCATION 51 KITCHEN

The skirting board to the left of the patio needs attention.

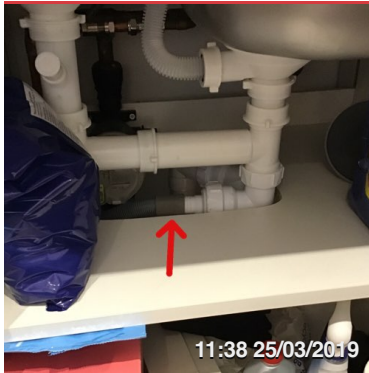
LOCATION 53 KITCHEN

The sink base shelf cut out needs sealing.

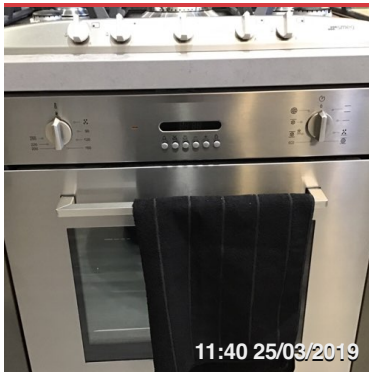
LOCATION 54 KITCHEN

The cooker has no power, it is possibly not connected at the rear.

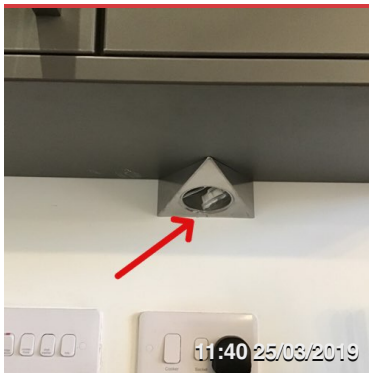
LOCATION 55 KITCHEN

The left hand light needs the bulb fitting.

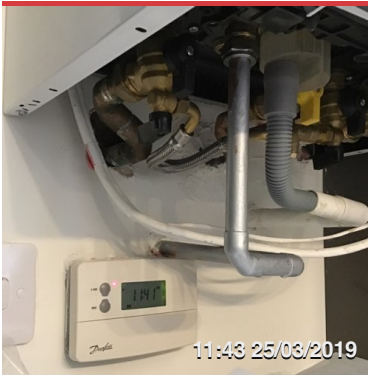
LOCATION 57 KITCHEN

The finish under the boiler needs attention.

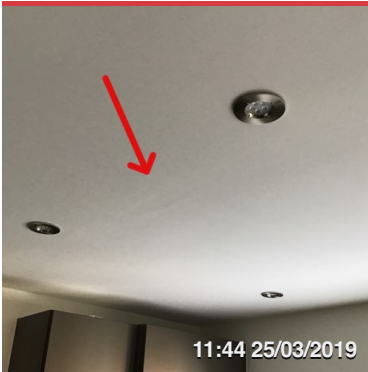
LOCATION 58 KITCHEN

The ceiling line in the kitchen area needs attention.

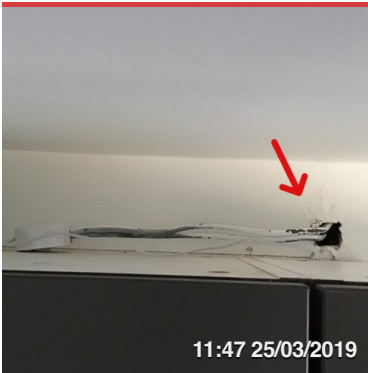
LOCATION 59 KITCHEN

There is a hole above the right hand wall units and the cables are visible.

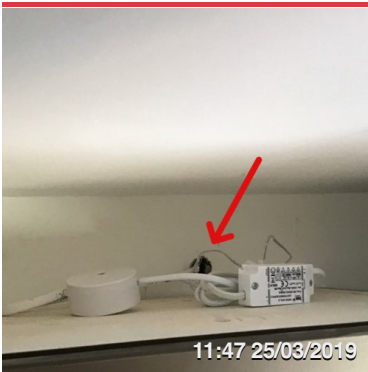
LOCATION 60 KITCHEN

There is a hole above the left hand wall units and the wires need tidying as they are visible from the room.

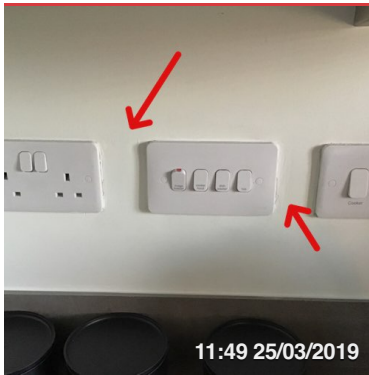
LOCATION 61 KITCHEN

Tidy around the sockets.

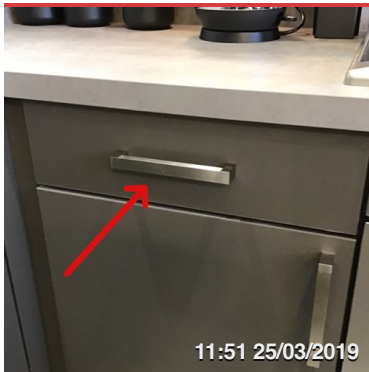
LOCATION 62 KITCHEN

The left hand drawer handle is damaged and scratched.

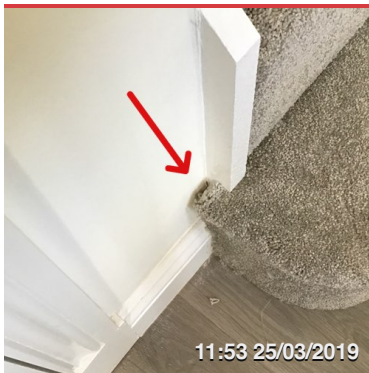
LOCATION 63 STAIRS

The finish on the bulnosed step needs attention and there is paint on the carpet.

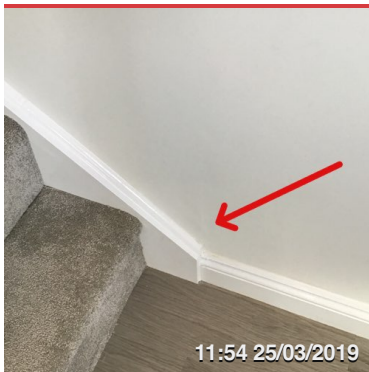
LOCATION 64 STAIRS

There is a board joint that needs filling on the right hand wall.

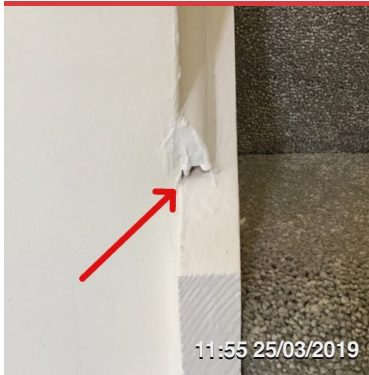
LOCATION 65 STAIRS

The bead to the top of left hand string needs filling.

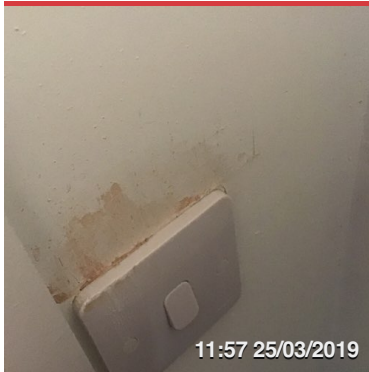
LOCATION 66 CYLINDER CUPBOARD

Touch up around the emersion heater switch.

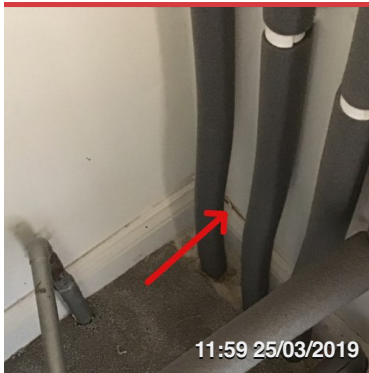
LOCATION 67 CYLINDER CUPBOARD

The skirting needs caulking and a general touch up.

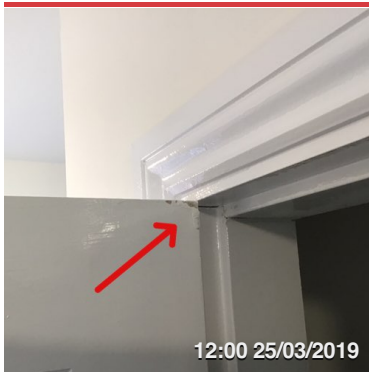
LOCATION 68 CYLINDER CUPBOARD

The door is damaged on the top.

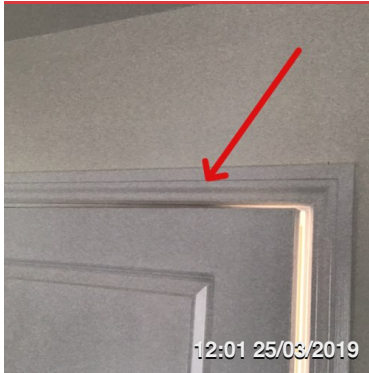
LOCATION 69 BEDROOM 3

The door is catching on the top.

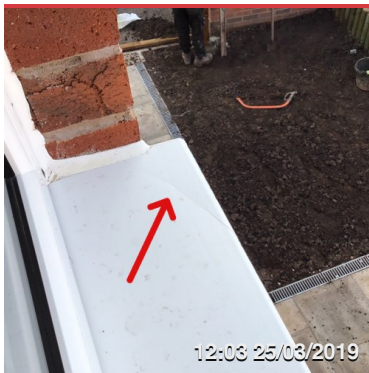
LOCATION 71 BEDROOM 3

The window sill is damaged and needs replacing.

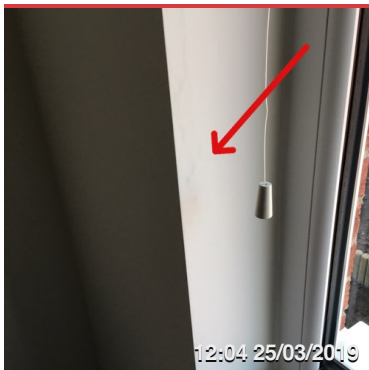
LOCATION 72 BEDROOM 3

The left hand window reveal needs filling and touch up.

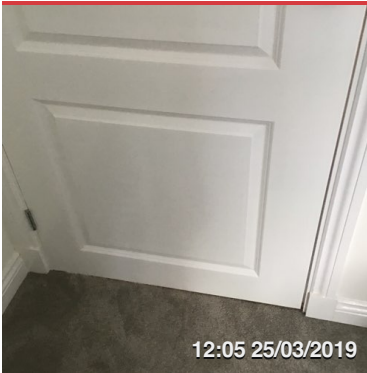
LOCATION 73 BEDROOM 2

The door needs packing out on the bottom hinge to adjust the margins.

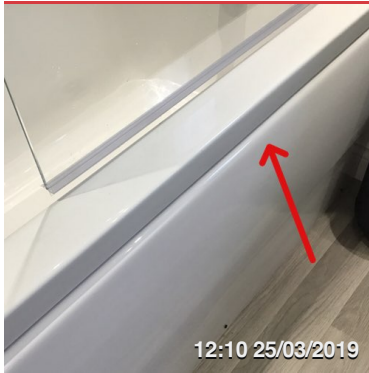
LOCATION 77 BATHROOM

The bath panel needs framing out at the top and the panel is running out of line.

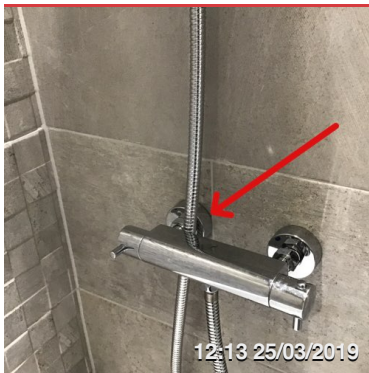
LOCATION 79 BATHROOM

The left hand shower control cover is loose, please check the pies have been sealed.

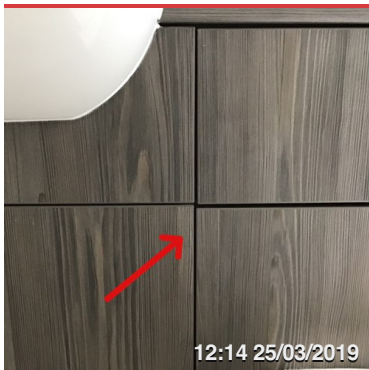
LOCATION 80 BATHROOM

The unit fronts need aligning.

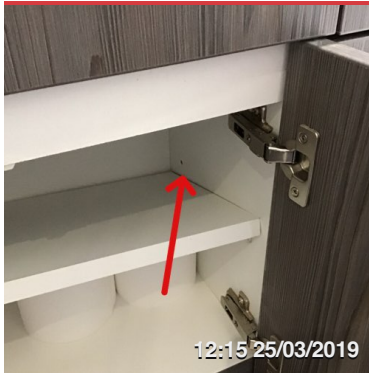
LOCATION 81 BATHROOM

The sink base unit shelf is missing a bracket.

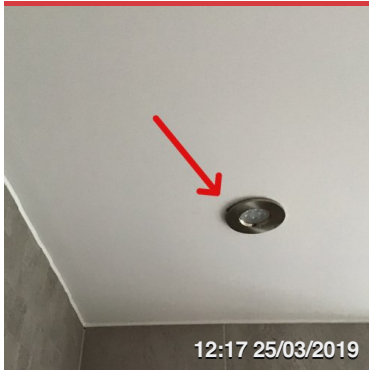
LOCATION 82 BATHROOM

Minor touch up required around the downlights.

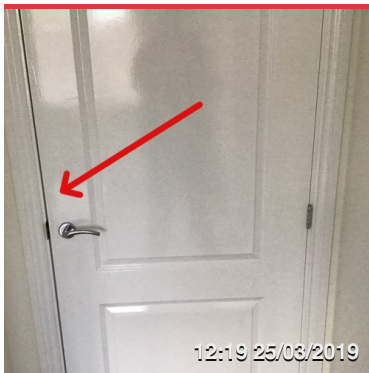
LOCATION 83 BEDROOM 1

The door needs packing out to even the margins, and the door tightening on the latch as it rattles.

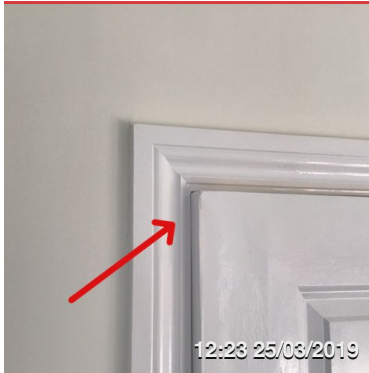
LOCATION 85 BEDROOM 1

The en suite door is catching and does not latch.

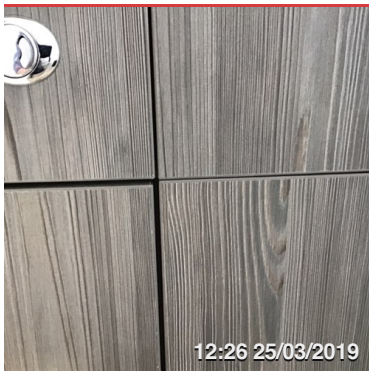
LOCATION 87 EN SUITE

The unit doors and panels need aligning

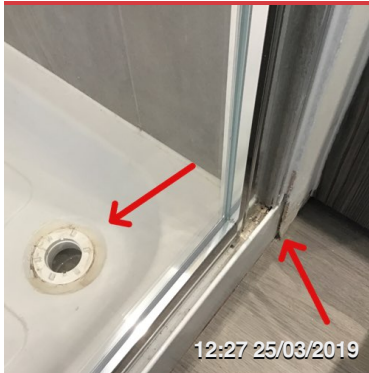
LOCATION 89 EN SUITE

The finish to the right of the shower needs finishing and the shower needs a plug.

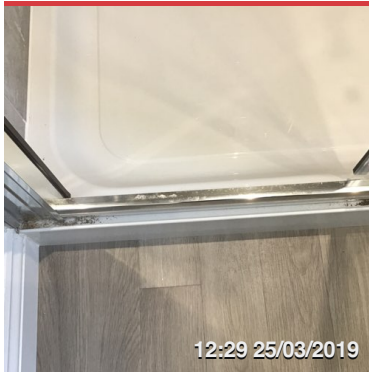
LOCATION 90 EN SUITE

The shower base needs cleaning.

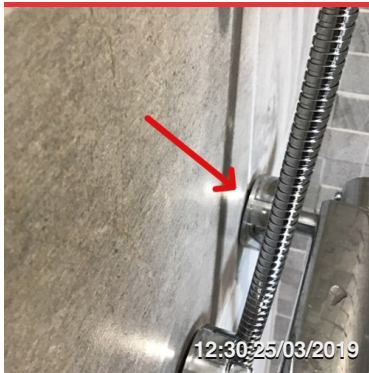
LOCATION 91 EN SUITE

There is a pin hole behind the right hand water feed and the covers need fitting properly check the pipes have been sealed.

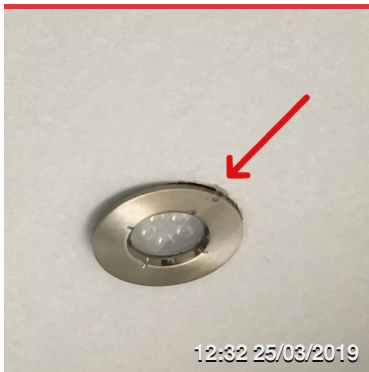
LOCATION 92 EN SUITE

The finish around the down lights need attention

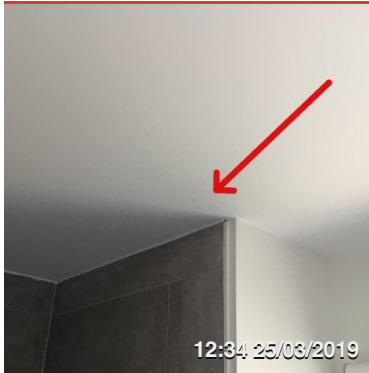
LOCATION 93 EN SUITE

The ceiling needs touching up, red mark.

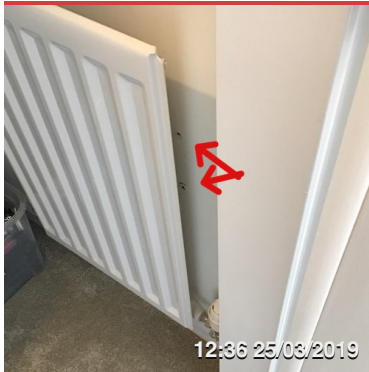
LOCATION 94 BEDROOM 1 WARDROBE

The fixing holes for the radiator need the plugs removing and filling.
