I Lively (Former CEnv FCIOB MCABE)
Lively Professional Services Ltd

37 STAUNTON DRIVE CARLISLE CUMBRIA CA1 3GU

Snagging Report

Friday, 14 August 2020

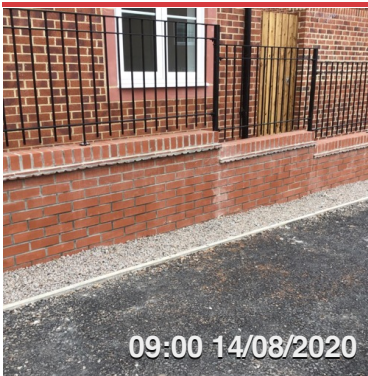
LOCATION 2 FRONT ELEVATION

The retaining and garden wall has mortar staining and needs cleaning.

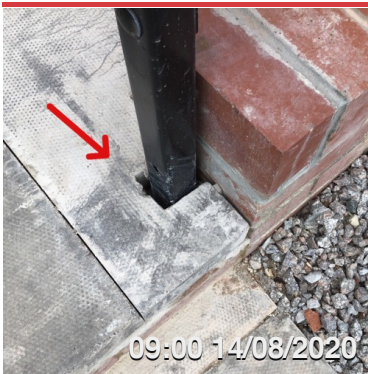
LOCATION 3 FRONT ELEVATION

The post is loose and needs fixing.

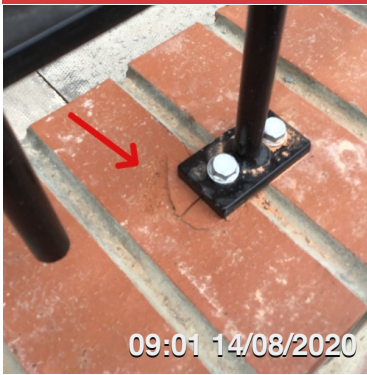
LOCATION 4 FRONT ELEVATION

The brick has been damaged when drilling the railing bracket.

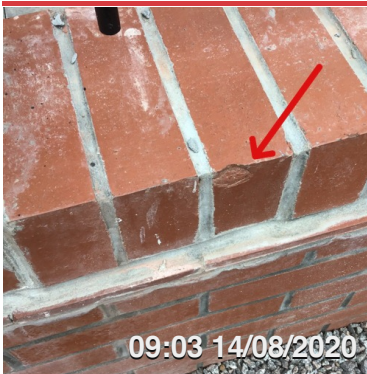
LOCATION 5 FRONT ELEVATION

The brick is damaged one needs replacing on the retaining wall.

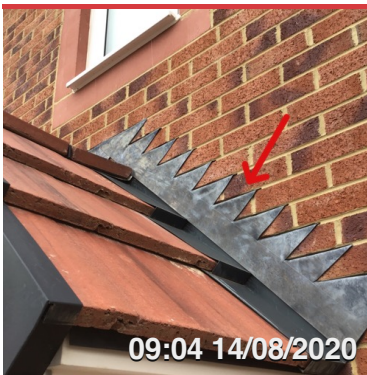
LOCATION 6 FRONT ELEVATION

The lead flashing over the canopy needs pointing.

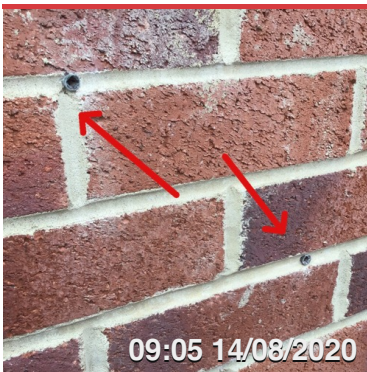
LOCATION 7 FRONT ELEVATION

The rawl plugs need removing where the plot board has been and pointing.

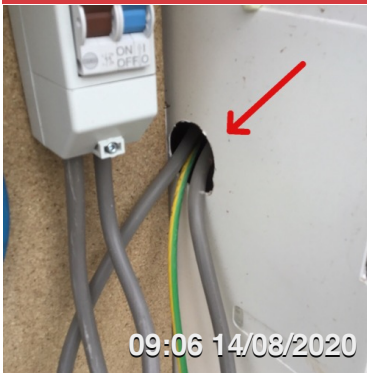
LOCATION 8 FRONT ELEVATION

The hole in the electric box needs sealing.

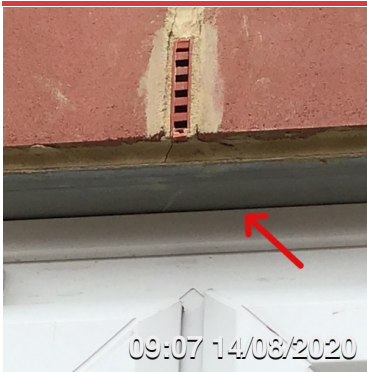
LOCATION 9 FRONT ELEVATION

The cover mould fitted to the top of the front windows needs sealing.

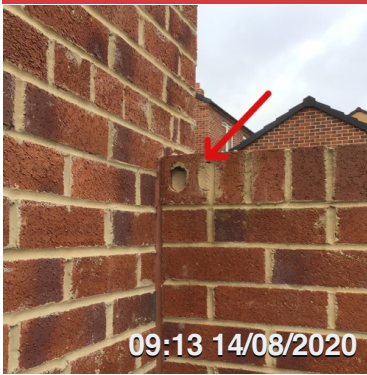
LOCATION 12 REAR GARDEN WALL

The hole in the brick needs pointing or replacing with a solid brick.

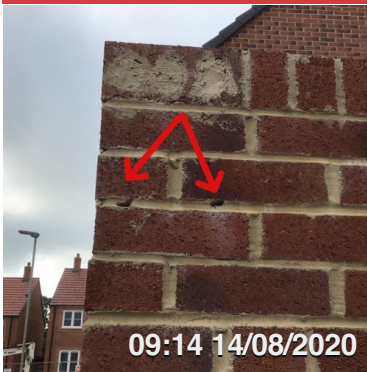
LOCATION 13 REAR GARDEN WALL

The bed joint need re pointing in several areas, where the bricklayer has had his pins

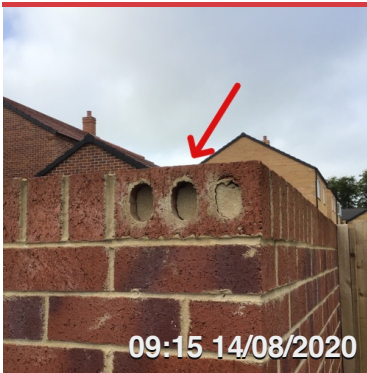
LOCATION 14 REAR GARDEN WALL

The holes in the brick need pointing or replacing with a solid brick.

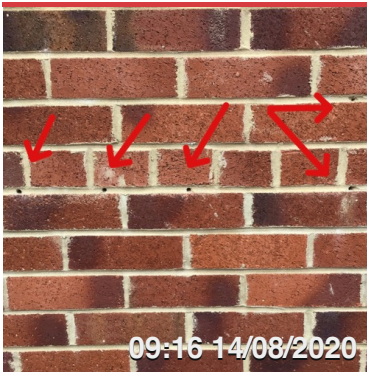
LOCATION 15 REAR GARDEN WALL

The drill holes in the bed joint need pointing.

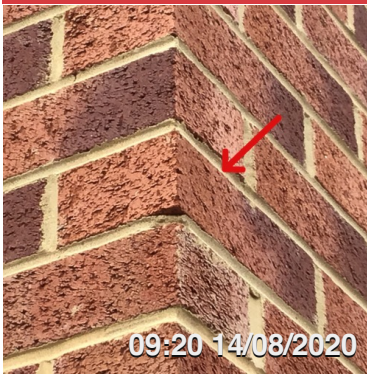
LOCATION 16 REAR ELEVATION

Small area of pointing required on the left hand corner.

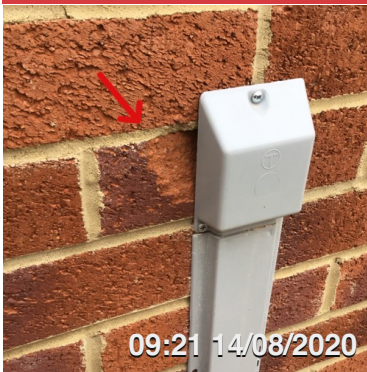
LOCATION 17 REAR ELEVATION

The damaged brick needs replacing behind the Telecoms cover.

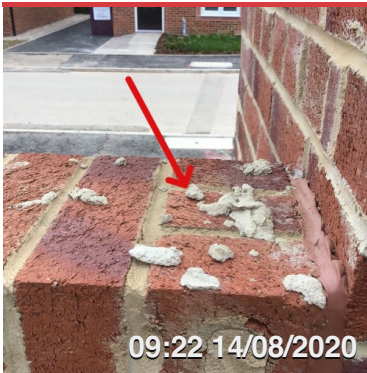
LOCATION 18 REAR GARDEN WALL

The mortar droppings need cleaning off the top of the rear garden wall.

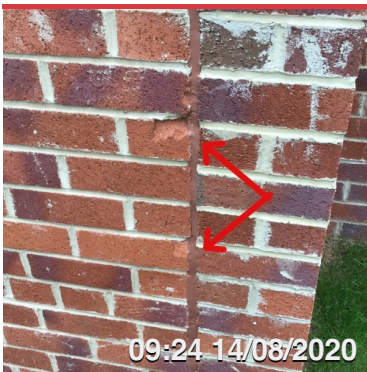
LOCATION 19 REAR GARDEN WALL

The two damaged bricks need replacing.

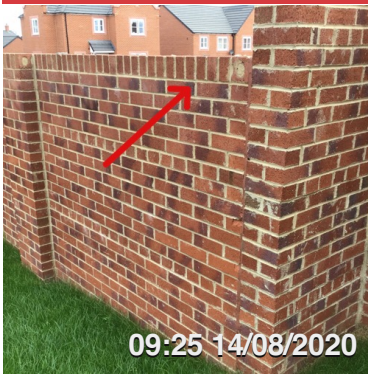
LOCATION 20 REAR GARDEN WALL

Please check the height of the garden wall in relation to the rear gardens ground level.

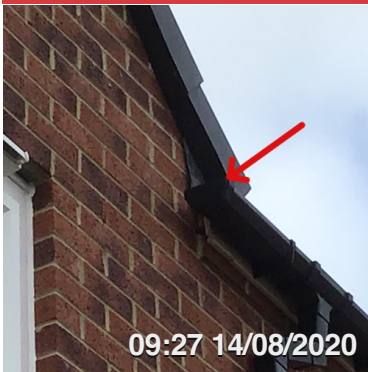
LOCATION 21 REAR ELEVATION

The fascia board needs a joint fitting where it has been joined and an end cap to close the gap at the end of the fascia to preventing infestation.

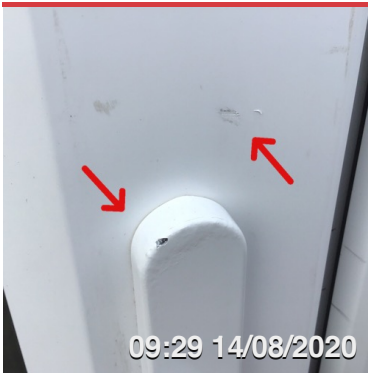
LOCATION 22 REAR ELEVATION

The patio handle is chipped and needs replacing, the frame is also scratched above it and needs repairing.

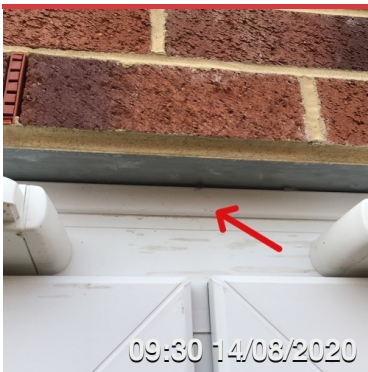
LOCATION 23 REAR ELEVATION

The cover mould fitted to the patio and bedroom window needs sealing.

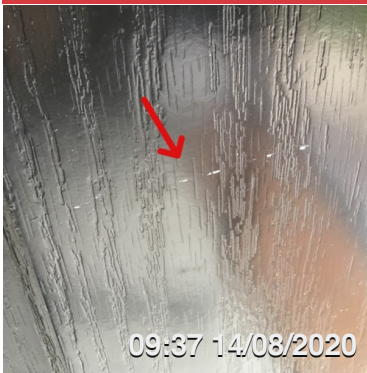
LOCATION 24 HALL

The front door is scratched in several places and needs repairing.

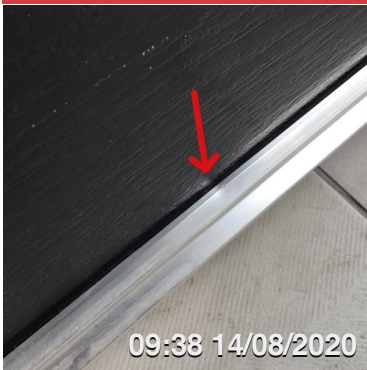
LOCATION 25 HALL

The metal weather strip on the front door is damaged and needs replacing.

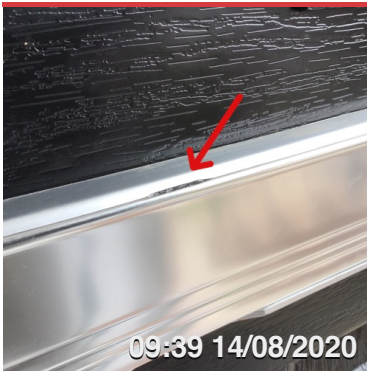
LOCATION 26 HALL

The front letter plate is damaged and needs replacing.

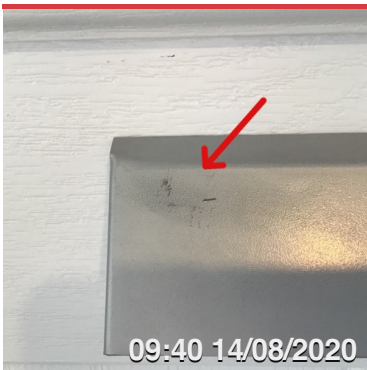
LOCATION 27 HALL

The rear letter plate cover is damaged and needs replacing.

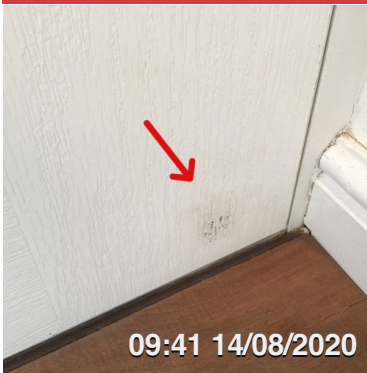
LOCATION 28 HALL

The rear of the front door is marked and needs repairing.

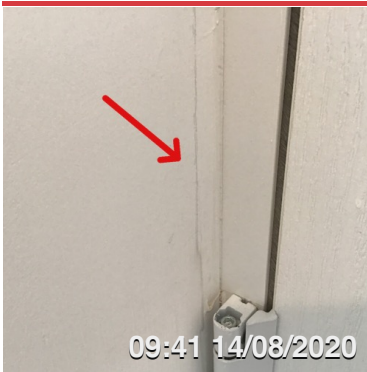
LOCATION 29 HALL

The left hand front door reveal needs touching up.

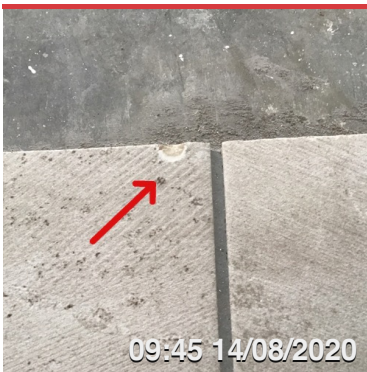
LOCATION 31 HALL

The floor tile is chipped at the lounge door.

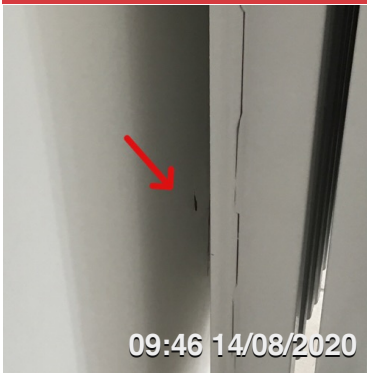
LOCATION 32 HALL

The wall behind the radiator needs filling where the plasterboard paper is delaminating.
The radiator is also out of level.

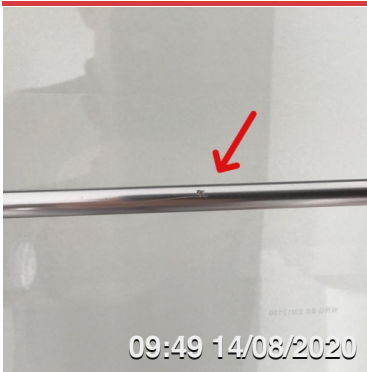
LOCATION 33 LOUNGE

The glazing bar in the door is damaged and needs replacing.

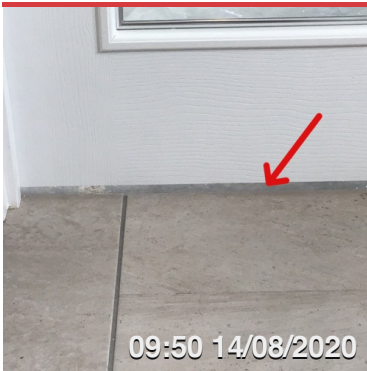
LOCATION 34 LOUNGE

The gap underneath the door is excessive.

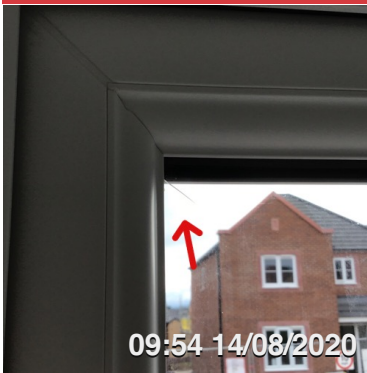
LOCATION 36 LOUNGE

The glass in the fixed unit is cracked and scratched in several places.

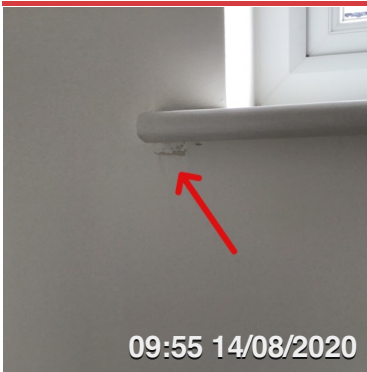
LOCATION 37 LOUNGE

The wall needs touching up underneath the window board.

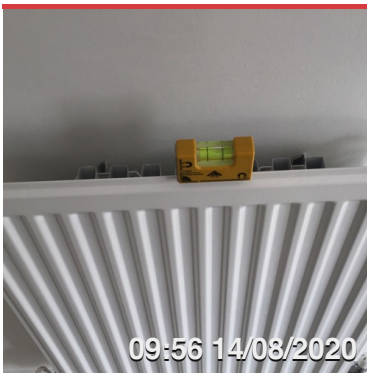
LOCATION 38 LOUNGE

The radiator is out of level.

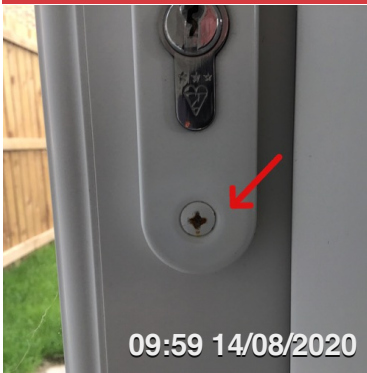
LOCATION 40 LOUNGE

The screws in the patio handles are rusty and need replacing.

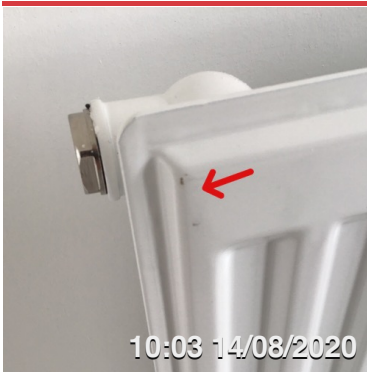
LOCATION 41 LOUNGE

The corner of the radiator needs touching up.

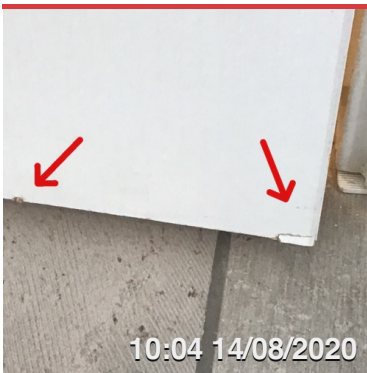
LOCATION 42 DOWNSTAIRS CLOAKS

The bottom of the door is damaged and needs repairing or replacing.

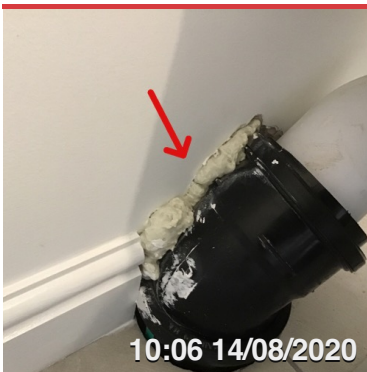
LOCATION 43 DOWNSTAIRS CLOAKS

There has clearly been a setting out issue with the drain position.

The expanding foam needs cleaning off and preferably box in the soil pipe.

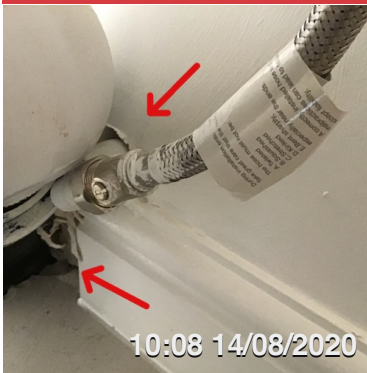
LOCATION 44 DOWNSTAIRS CLOAKS

The wall needs filling around the pipes behind the toilet.

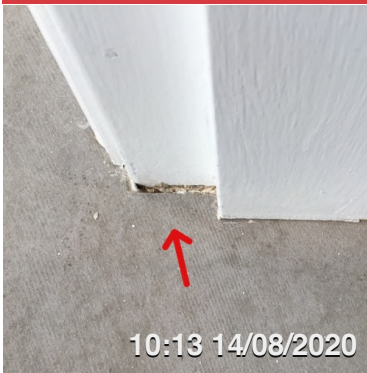
LOCATION 48 KITCHEN

Both sides of the kitchen door tiles needs sealing.

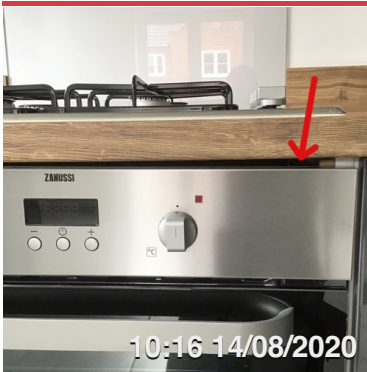
LOCATION 49 KITCHEN

The hob needs refitting level.

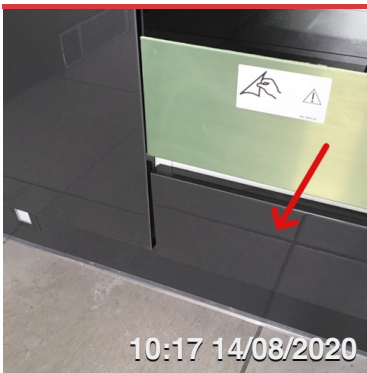
LOCATION 50 KITCHEN

The panel underneath the oven is loose.

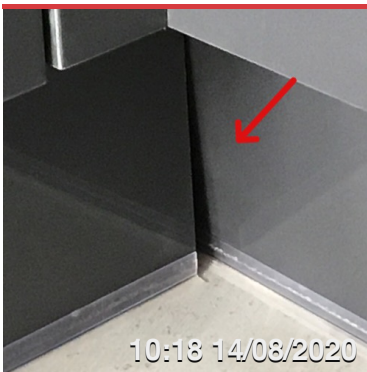
LOCATION 51 KITCHEN

The plinth underneath the oven needs refitting.

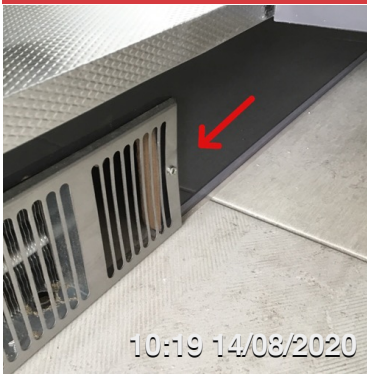
LOCATION 52 KITCHEN

The screw in the plinth heater cover has been over tightening and is buckling the cover.

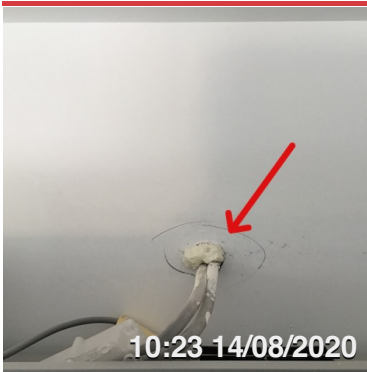
LOCATION 53 KITCHEN

The expanding foam needs cleaning from the wires above the extractor and the wall needs filling and touching up.

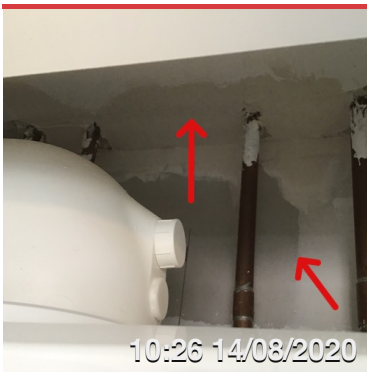
LOCATION 55 KITCHEN

The wall and ceiling in the boiler cupboard need sanding and painting.

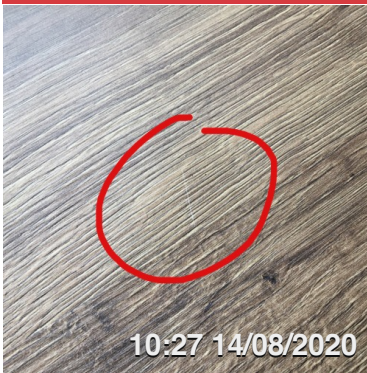
LOCATION 56 KITCHEN

The worktop is scratched to the right of the sink and needs repairing or replacing.

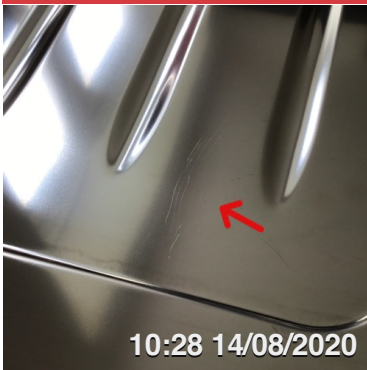
LOCATION 57 KITCHEN

The sing is scratched in several places and needs repairing or replacing.

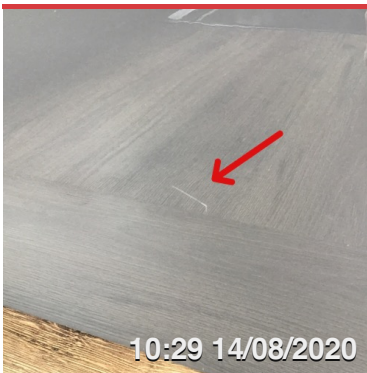
LOCATION 58 KITCHEN

The panel below the boiler cupboard door is scratched and needs replacing.

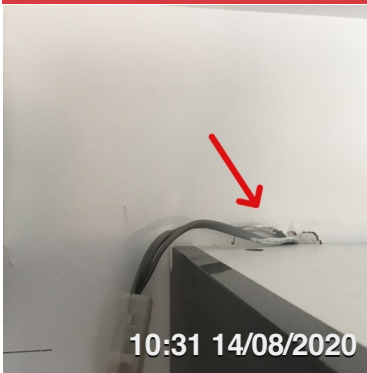
LOCATION 60 KITCHEN

The wall needs filling and touching up above the wall units

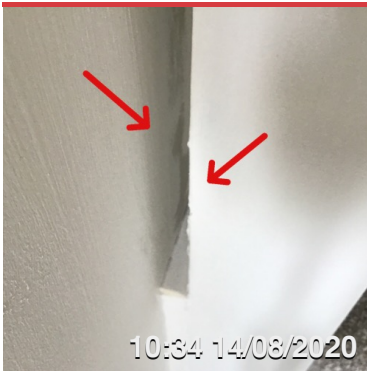
LOCATION 62 STAIRS TO FIRST FLOOR

The filler needs sanding off the newel and the wall touching up behind it.

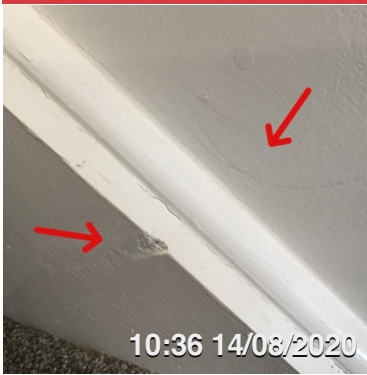
LOCATION 64 STAIRS TO FIRST FLOOR

The right hand string needs filling and the wall touching up.

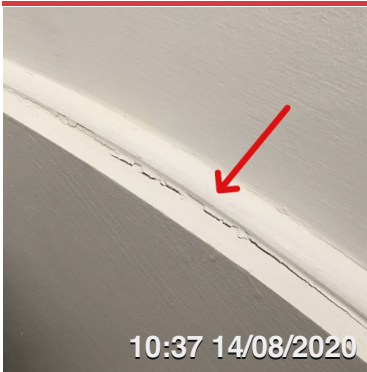
LOCATION 65 STAIRS TO FIRST FLOOR

The right hand string needs caulking.

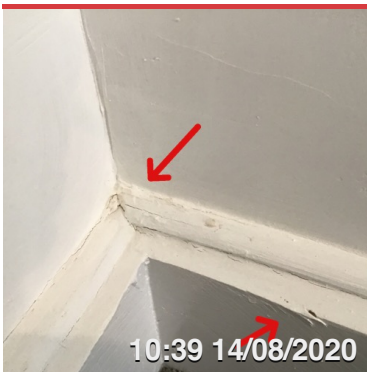
LOCATION 67 STAIRS TO FIRST FLOOR

The beading mitre needs sanding and filling, the string also need filling.

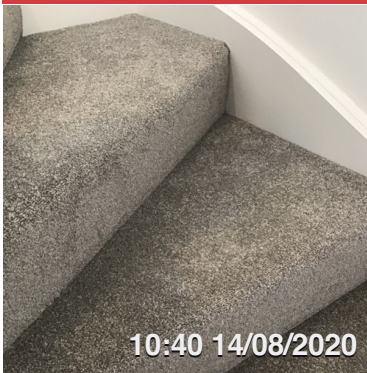
LOCATION 68 STAIRS TO FIRST FLOOR

The kite winders are loose on the risers and need more glue, or glue blocks fitting to prevent them from moving.

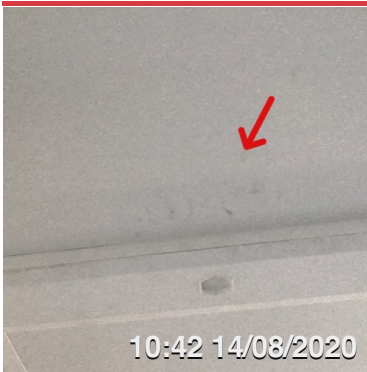
LOCATION 69 LANDING

The ceiling needs touching up next to the loft trap.

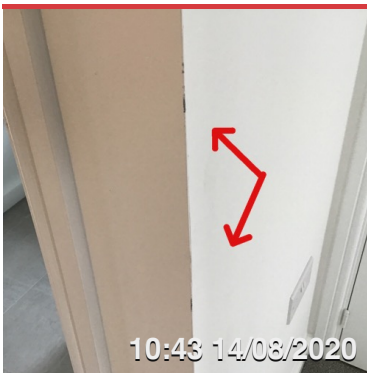
LOCATION 70 LANDING

The corner bead needs touching up.

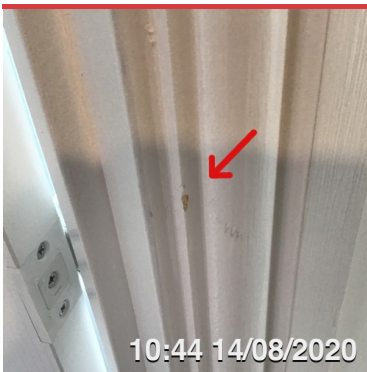
LOCATION 71 LANDING

The bathroom architrave needs touching up.

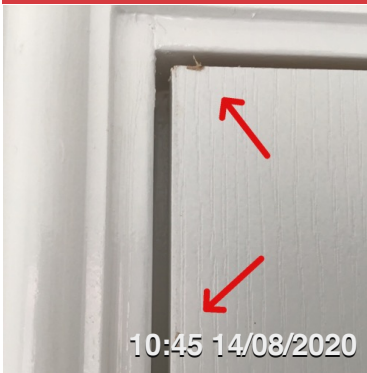
LOCATION 72 BEDROOM 2

The door is damaged and needs touching up.

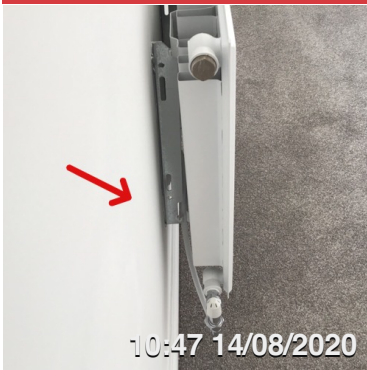
LOCATION 73 BEDROOM 3

The radiator is not sat on the bottom bracket.

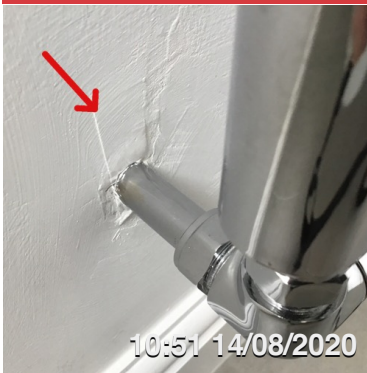
LOCATION 76 BATHROOM

The wall around the towel radiator pipes needs sanding and shrouds fitting.

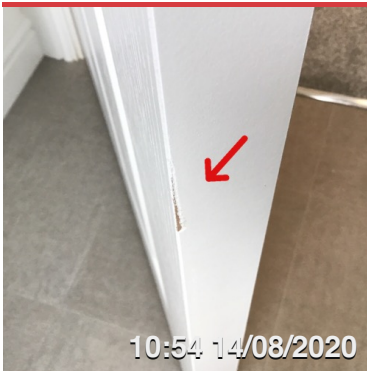
LOCATION 78 BATHROOM

The bathroom door is damaged.

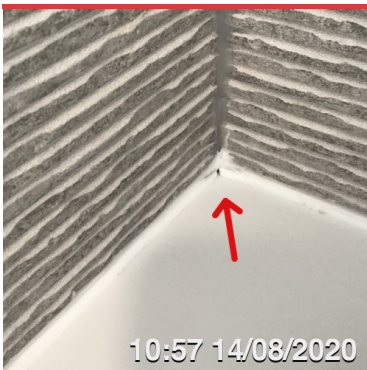
LOCATION 79 BATHROOM

The sealant on the rear of the bath has a pin hole.

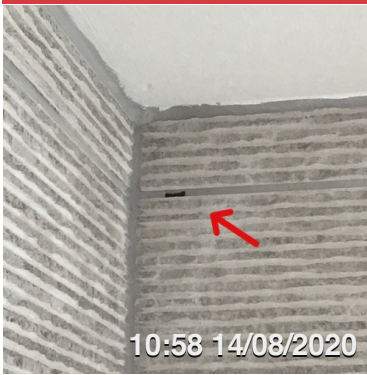
LOCATION 80 BATHROOM

The pin hole needs re grouting to the left of the shower head.

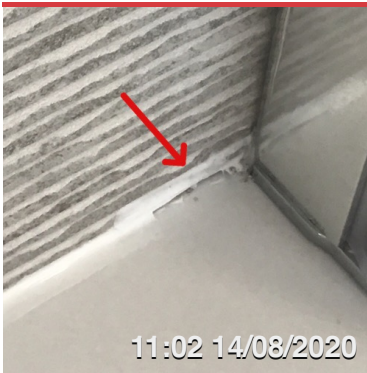
LOCATION 82 BATHROOM

The sealant is missing in the corner next to the shower screen.

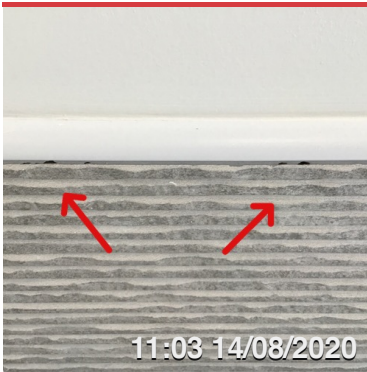
LOCATION 83 BATHROOM

The tiles need the pin holes grouting in the sink splash back.

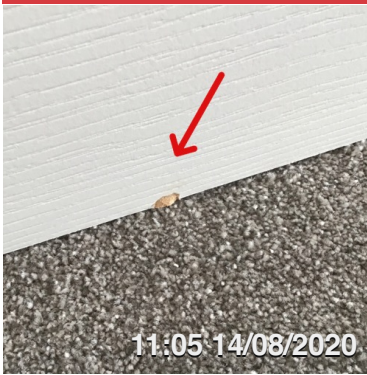
LOCATION 84 BEDROOM 1

The bottom of the door is damaged.

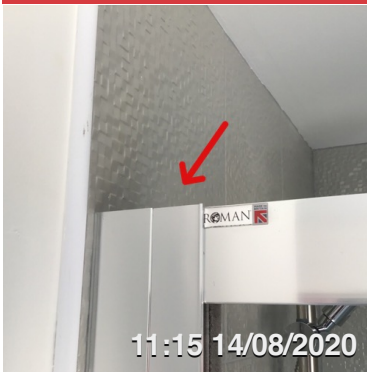
LOCATION 85 EN SUITE

The left hand cap is missing on the shower door frame.

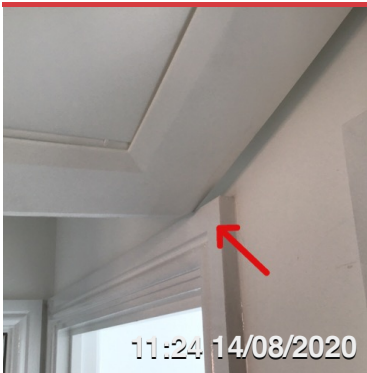
LOCATION 86 LANDING

The loft trap door is catching the architrave.

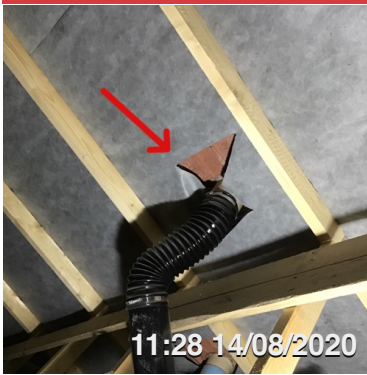
LOCATION 88 ROOF SPACE

The cut out in the felt around the tile vent is excessive.
