I Lively (Former CEnv FCIOB MCABE)
Lively Professional Services Ltd

5 GRAYLING ROAD SANDBACH CHESHIRE CW11 4AS

Snagging Report

Monday, 14 September 2020

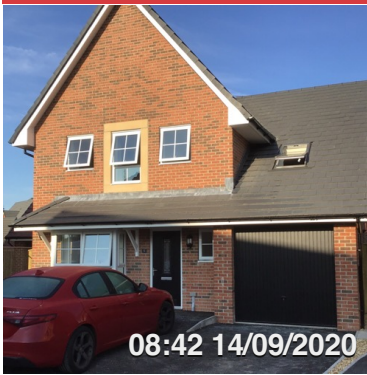
LOCATION 1 5 GRAYLING ROAD SANDBACH

The house has been built to a good standard throughout, there are a number of minor defects that need attention, which could have been avoided with a little more attention to detail.

The extractor and boiler flue ducts need cavity trays installing (NHBC Standards 2020 Chapter 6.1.17)

The majority of fire doors need adjusting throughout the house to comply with building regulations, the margins should be between 2 & 4mm.

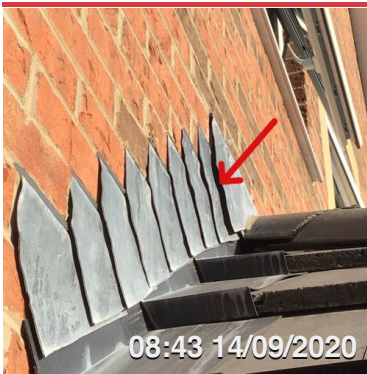
LOCATION 2 FRONT ELEVATION

The lead flashing needs dressing flat to the wall to prevent water ingress.

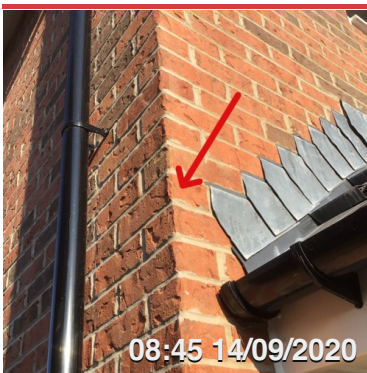
LOCATION 3 FRONT ELEVATION

No weephole at the end of the cavity tray.

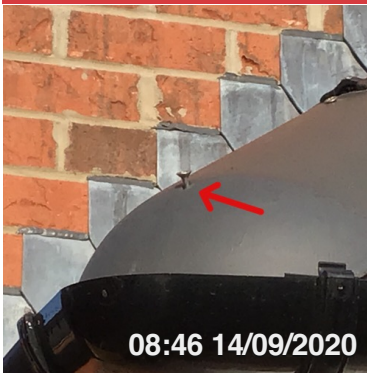
LOCATION 4 FRONT ELEVATION

The screw needs tightening in the bottom left hand ridge tile.

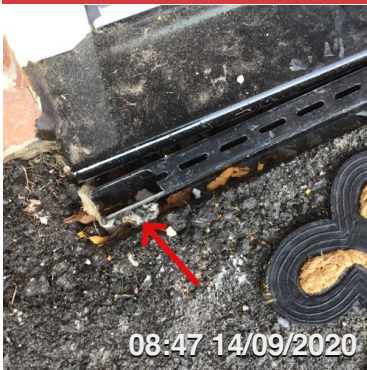
LOCATION 5 FRONT ELEVATION

The drainage chanel at the front door is damaged and needs replacing before the drive is final surfaced.

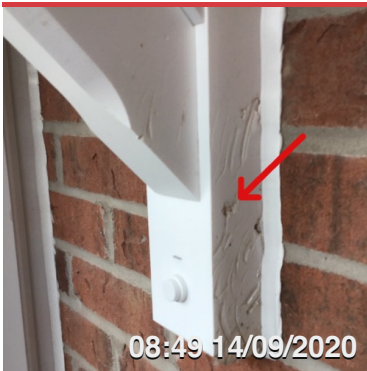
LOCATION 6 FRONT ELEVATION

The gallows bracket to the left of the front door is damaged and needs repairing or replacing.

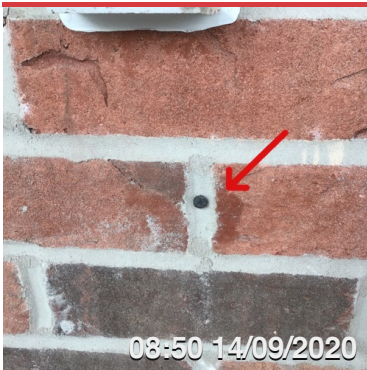
LOCATION 7 FRONT ELEVATION

The nail needs removing where the plot board has been and repointing.

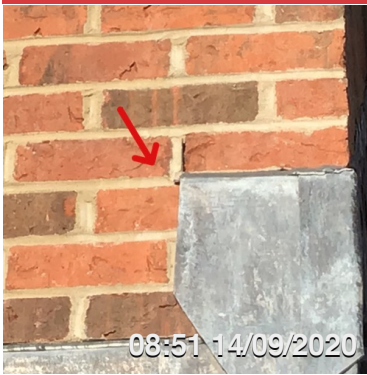
LOCATION 8 FRONT ELEVATION

There is no weep hole at the end of the cavity tray.

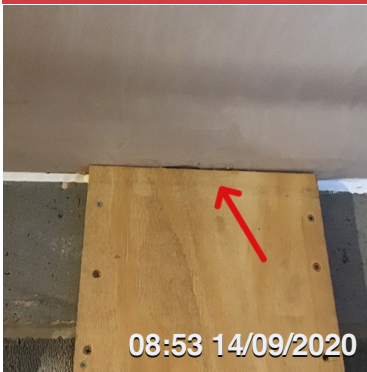
LOCATION 9 GARAGE

The top of the boxing needs sealing with intumescent sealant.

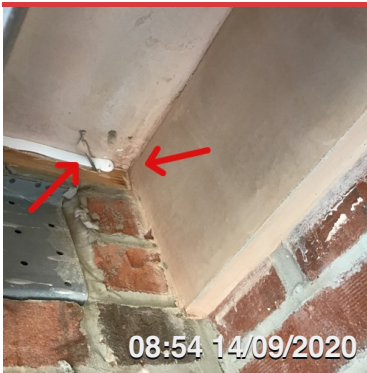
LOCATION 10 GARAGE

The nail needs removing from the wall plate and the intumescent sealant needs finishing.

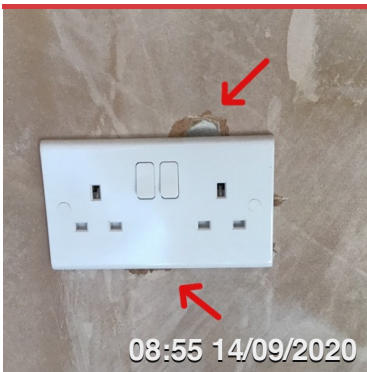
LOCATION 11 GARAGE

The wall needs patching around the double socket.

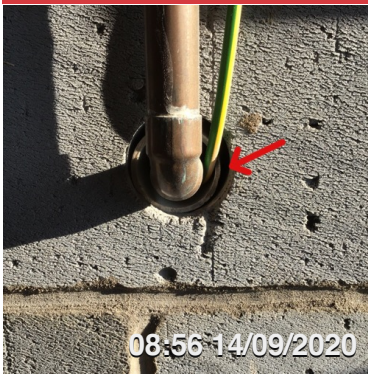
LOCATION 12 GARAGE

The duct needs sealing between the duct and blockwork.

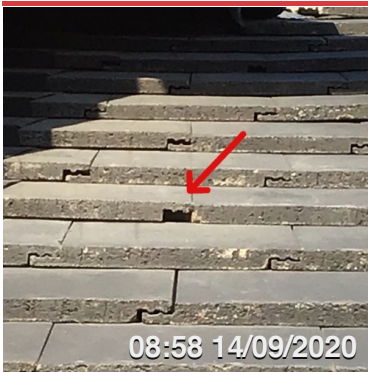
LOCATION 13 FRONT ELEVATION

There are a number of tiles on the roof with the channels damaged and need replacing.

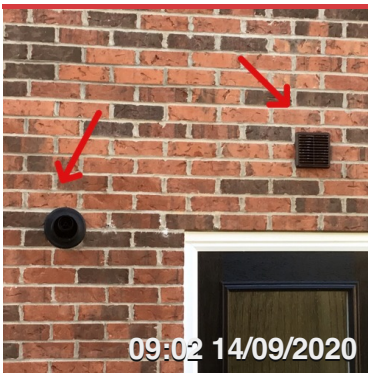
LOCATION 14 RIGHT HAND ELEVATION

There are no cavity trays installed above the gas flue and extractor duct.

NHBC Standards 6.1.17

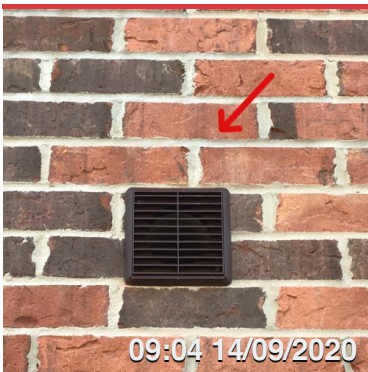
LOCATION 15 REAR ELEVATION

The extractor duct needs a cavity tray above it.

NHBC Standards 6.1.17

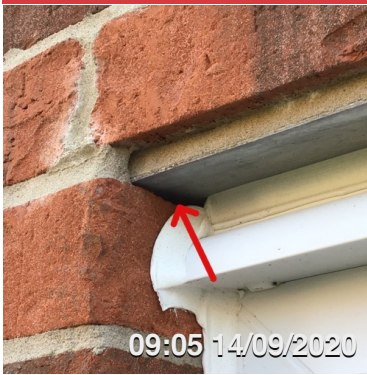
LOCATION 16 REAR ELEVATION

The left hand patio lintel has been dry bedded and needs pointing.

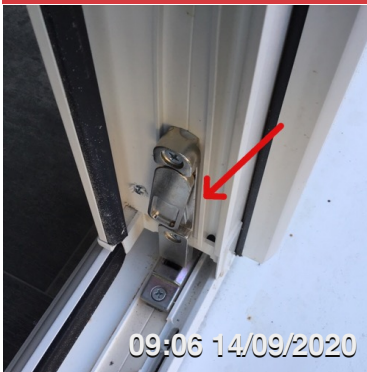
LOCATION 17 REAR ELEVATION

The left hand patio, right hand door bottom lock is hard to open and needs adjusting.

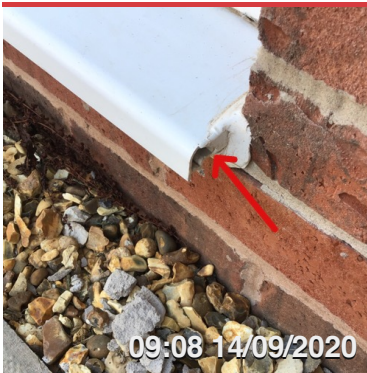
LOCATION 18 REAR ELEVATION

The left hand patio cill needs a new end cap.

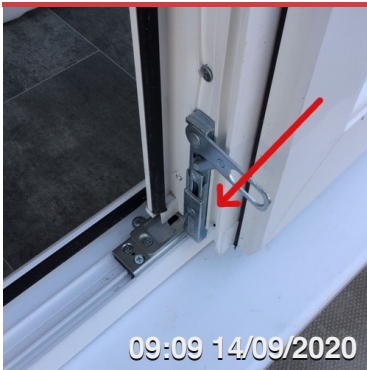
LOCATION 19 REAR ELEVATION

The patio door is catching and needs adjusting slightly.

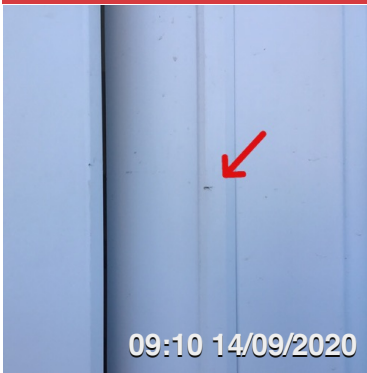
LOCATION 20 REAR ELEVATION

The patio cover mould is cut and needs repairing to the right of the main patio doors.

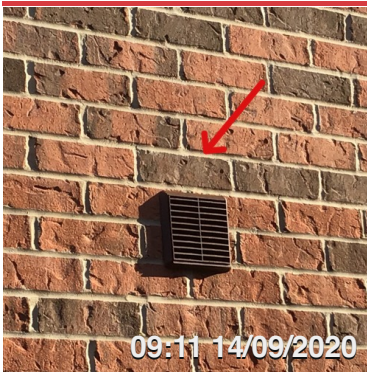
LOCATION 21 LEFT HAND ELEVATION

There is no cavity tray above the kitchen extractor duct.
NHBC Standards 6.1.17

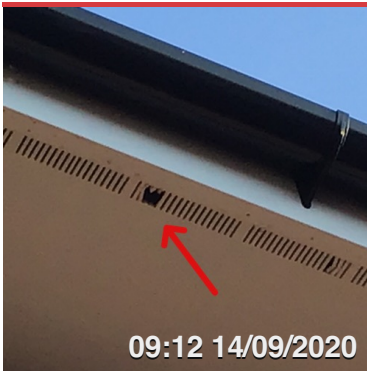
LOCATION 22 LEFT HAND ELEVATION

The soffit grill is damaged and needs replacing to prevent infestation.

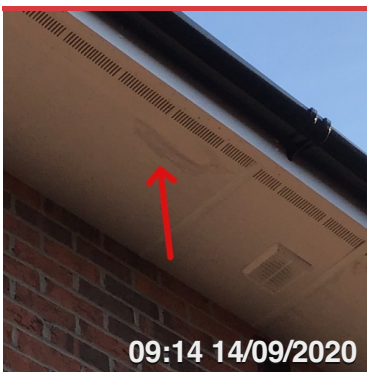
LOCATION 23 LEFT HAND ELEVATION

The plastic protection needs removing from the soffit.

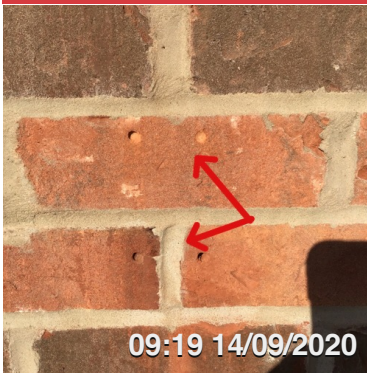
LOCATION 24 FRONT ELEVATION

The bricks need replacing where they have been drilled to the right of the front door.

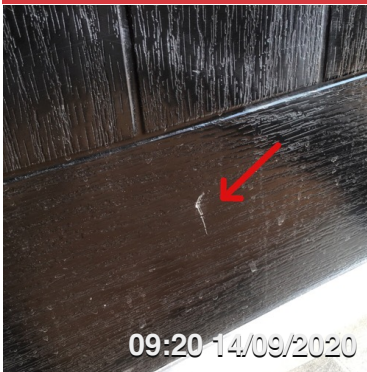
LOCATION 25 HALL

The front door is marked in several areas and needs repairing.

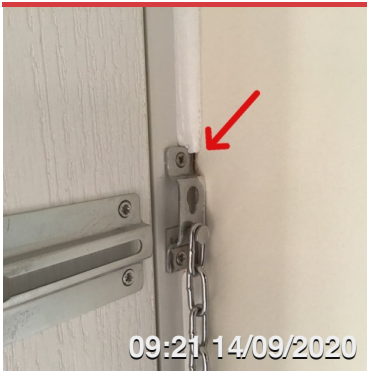
LOCATION 26 HALL

The frame needs sealing around the door chain.

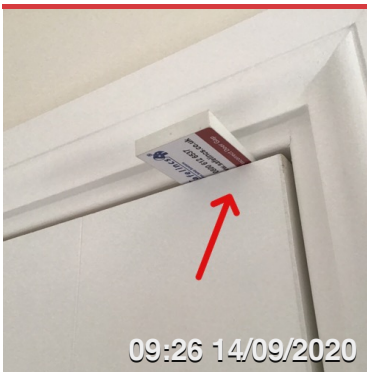
LOCATION 27 HALL CUPBOARD

The head of the cupboard fire door needs adjusting slightly to comply with building regulations.

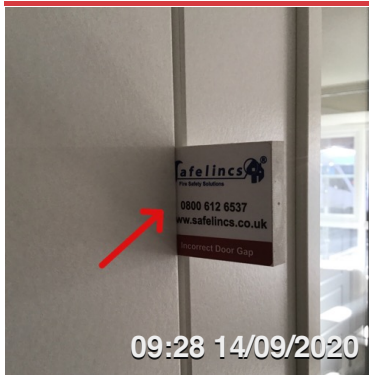
LOCATION 28 LOUNGE

The lounge fire doors need the margin adjusting slightly to comply with building regulations.

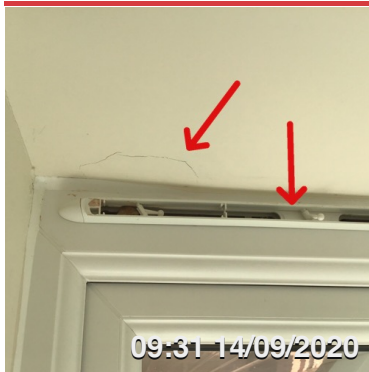
LOCATION 29 LOUNGE

The left hand trickle vents needs replacing and the ceiling needs filling.

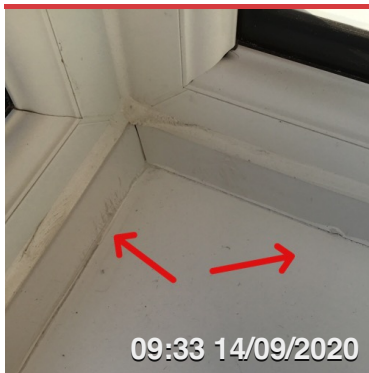
LOCATION 30 LOUNGE

The window board trim is scratched and needs repairing.

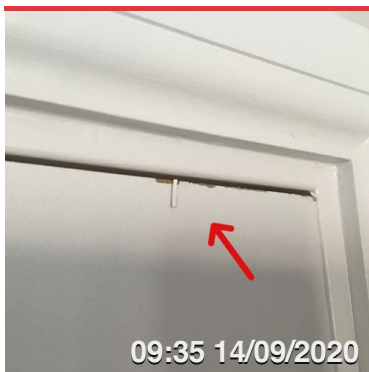
LOCATION 31 KITCHEN

The top of the door is damaged and needs repairing or replacing.

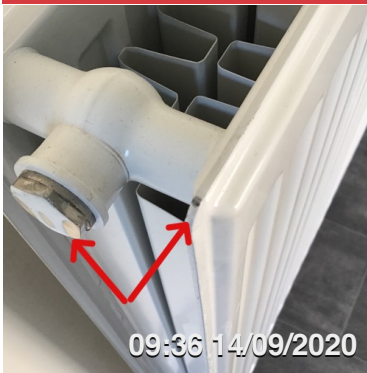
LOCATION 32 KITCHEN

The radiator plug needs the paint removing and the radiator needs touching up.

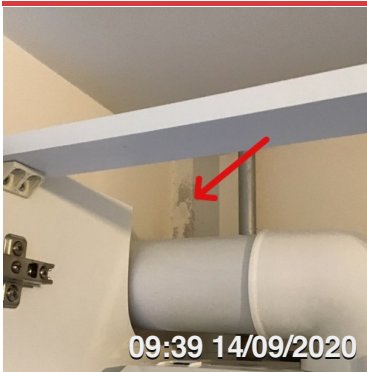
LOCATION 33 UTILITY

The wall needs touching up above the boiler.

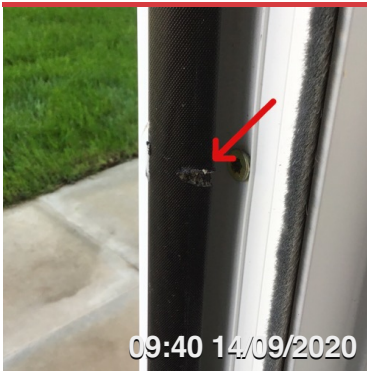
LOCATION 34 UTILITY

The draft seal is damaged and needs replacing.

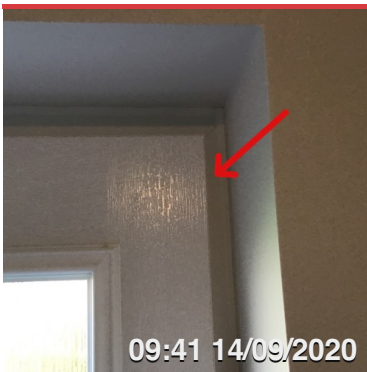
LOCATION 35 UTILITY

The utility door is catching at the top and needs slightly adjusting.

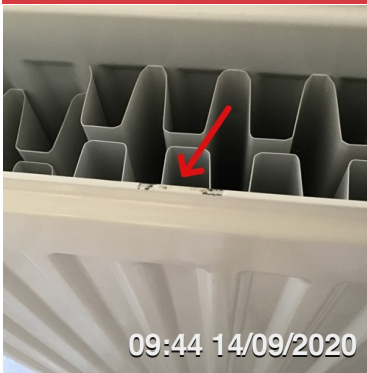
LOCATION 36 KITCHEN

The top edge of the radiator is damaged and needs touching up.

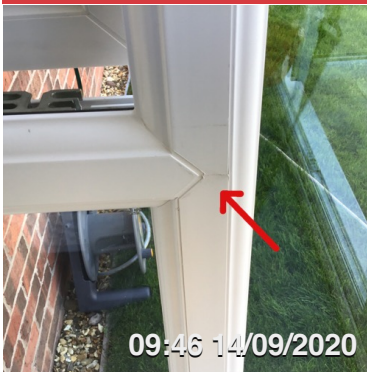
LOCATION 37 KITCHEN

The left hand bay return frame has a cut mark that needs repairing.

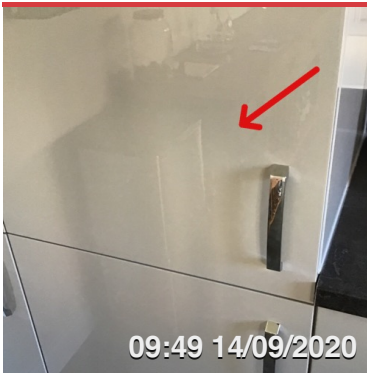
LOCATION 38 KITCHEN

The fridge door is scraping on the integrated bracket.

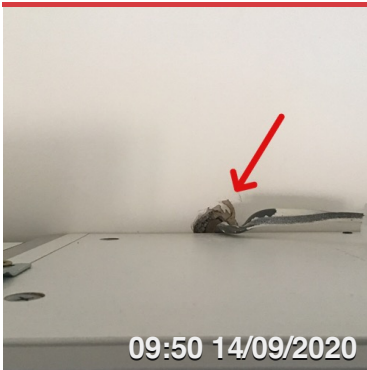
LOCATION 39 KITCHEN

The hole above the left hand wall units for the under pelmet lights needs filling.

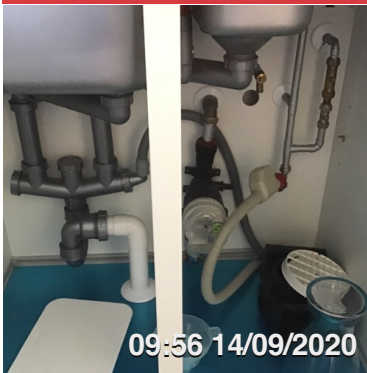
LOCATION 40 KITCHEN

The sink base unit needs a shelf fitting.

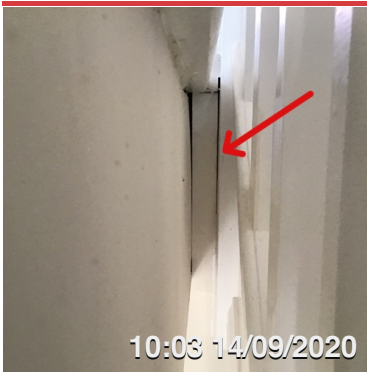
LOCATION 41 STAIRS TO FIRST FLOOR

The filler between the trimmer and stairs needs caulking.

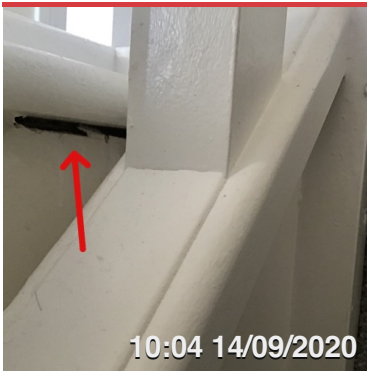
LOCATION 42 STAIRS TO FIRST FLOOR

The wall needs filling underneath the nosing.

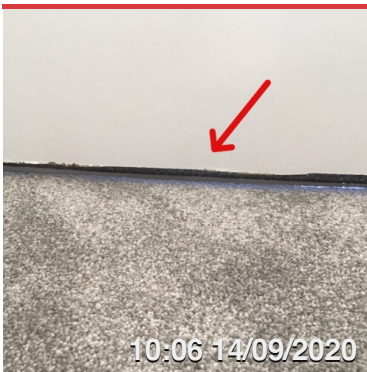
LOCATION 43 BEDROOM 4

The bottom of the door has been poorly cut by the carpet fitters and needs replacing.

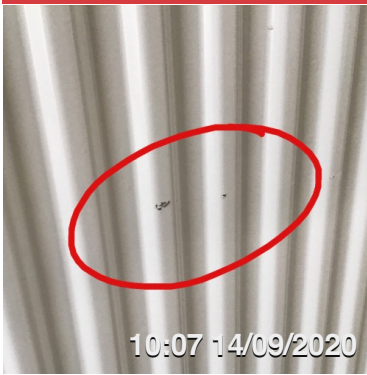
LOCATION 44 BEDROOM 4

The radiator is damaged and needs repairing.

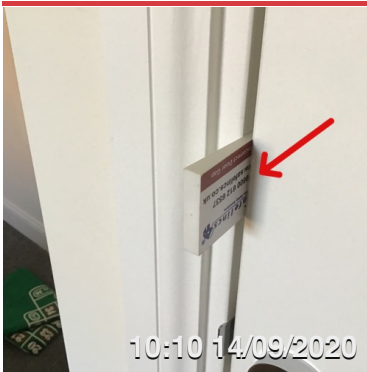
LOCATION 45 BEDROOM 3

The fire door margins are in excess of 4mm and needs adjusting to comply with building regulations.(2-4mm)

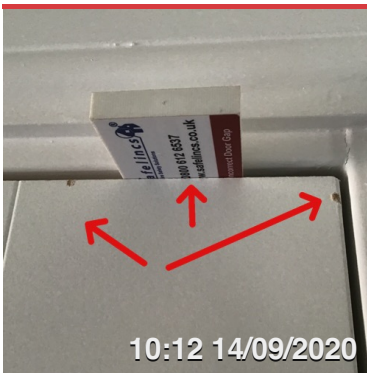
LOCATION 46 CYLINDER CUPBOARD

The top of the door is damaged and the fire door margins are in excess of 4mm and needs adjusting to comply with building regulations (2-4mm)

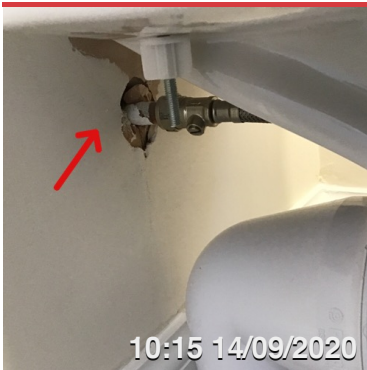
LOCATION 47 BATHROOM

The wall needs filling around the toilet water pipe.

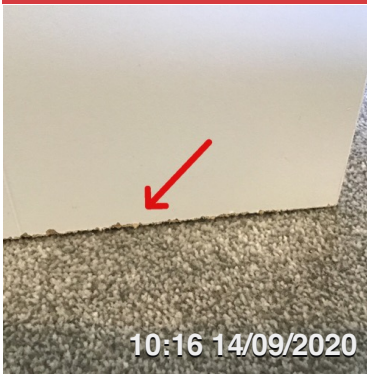
LOCATION 48 BEDROOM 2

The bottom of the door needs touching up where the carpet fitters have cut it.

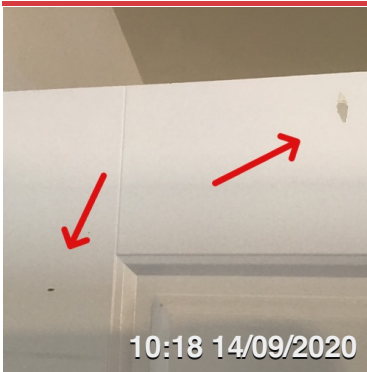
LOCATION 49 BEDROOM 2

The top of the door is damaged and needs repairing.

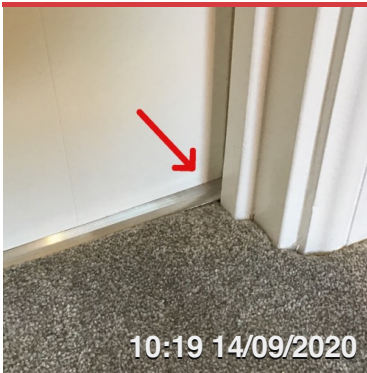
LOCATION 50 BEDROOM 2 EN SUITE

The bottom of the door is catching on the carpet trim and needs adjusting.

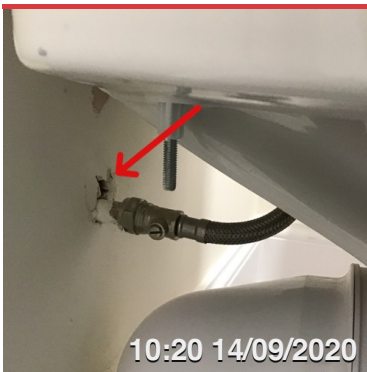
LOCATION 51 BEDROOM 2 EN SUITE

The wall needs filling around the toilet water pipe.

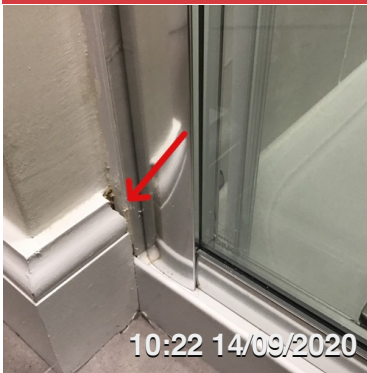
LOCATION 52 BEDROOM 2 EN SUITE

The left hand skirting board needs caulking next to the shower.

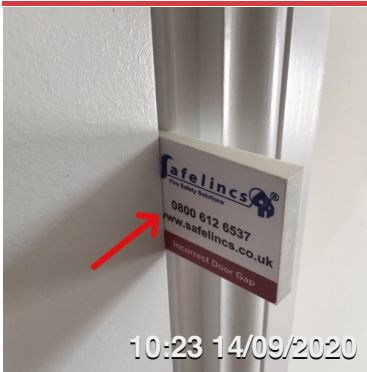
LOCATION 53 BEDROOM 1

The fire door margins are in excess of 4mm and needs adjusting to comply with building regulations (2-4mm)

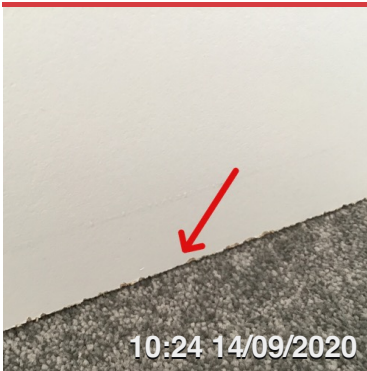
LOCATION 54 BEDROOM 1

The bottom of the door is damaged where the carpet fitters have cut it.

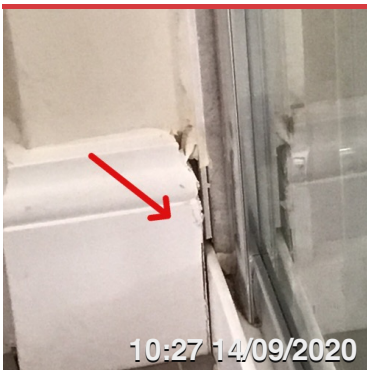
LOCATION 55 EN SUITE

The skirting boards at both sides of the shower tray need caulking.

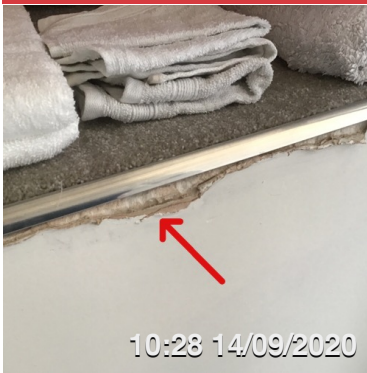
LOCATION 56 BEDROOM 5

The bulk head panel needs patching.

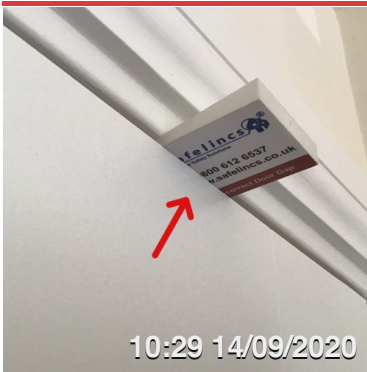
LOCATION 57 BEDROOM 5

The fire door margins are in excess of 4mm and needs adjusting to comply with building regulations (2-4mm)

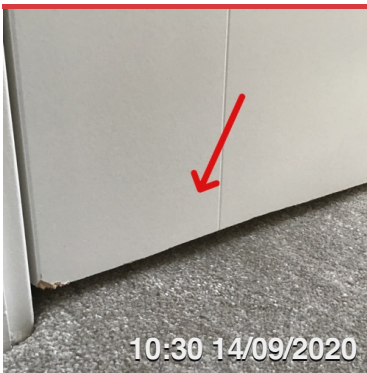
LOCATION 58 BEDROOM 5 CUPBOARD

The bottom of the door has been poorly cut by the carpet fitters and needs replacing.

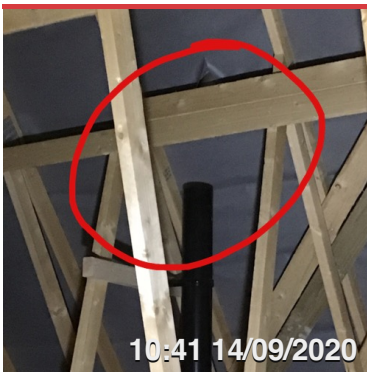
LOCATION 59 ROOF SPACE

The soil pipe needs connecting to the roof tile vent.
