I Lively (Former CEnv FCIOB MCABE)
Lively Professional Services Ltd

93 ST KEVINS DRIVE KIRKBY LIVERPOOL L32 1BB

Snagging Report

Tuesday, 22 September 2020

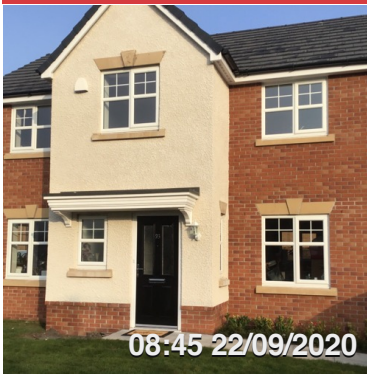
LOCATION 1 93 ST KEVIN'S DRIVE KIRKBY L32 1BB

The overall finish of the house is poor with little attention to detail, in particular the decoration throughout is a poor standard and gives the house the feeling that it was rushed to completion.

The extractor ducts and boiler flue require cavity trays installing to comply with NHBC Standards Chapter 6.1.17

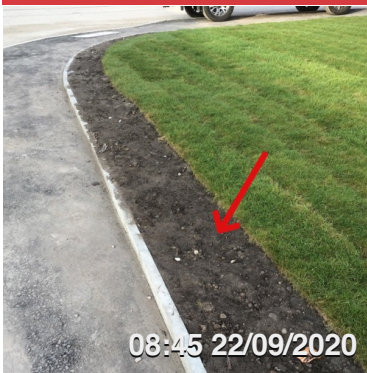
LOCATION 2 FRONT ELEVATION

Assigned To Landscaper
The front bed needs planting.

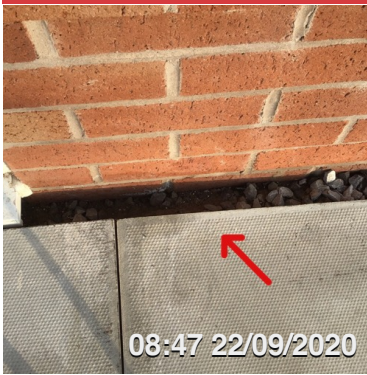
LOCATION 4 FRONT ELEVATION

The gap both sides of the front door needs filling with limestone chippings.

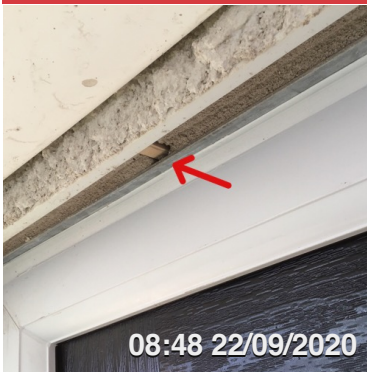
LOCATION 5 FRONT ELEVATION

The timber needs removing from over the front door lintel.

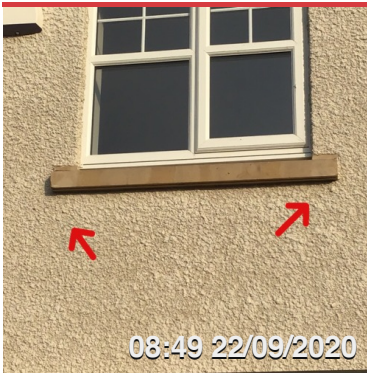
LOCATION 6 FRONT ELEVATION

The artstone cill is damaged and needs repairing. If the cill is painted the other artstone will need painting to match.

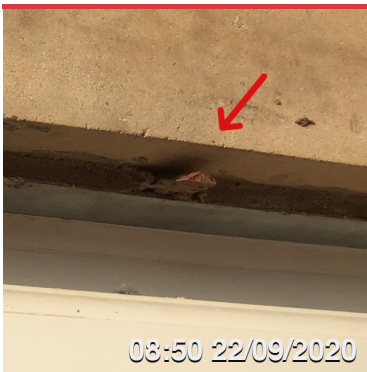
LOCATION 7 FRONT ELEVATION

The brick packer needs removing from underneath the head on the right hand hall window.

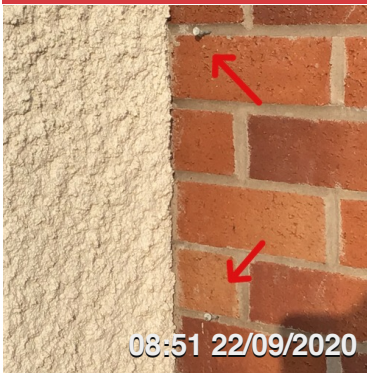
LOCATION 8 FRONT ELEVATION

The nails need removing from the brickwork and repointing to the left of the kitchen window.

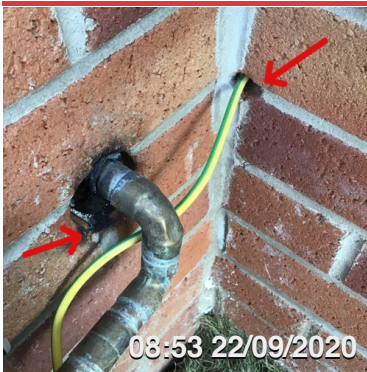
LOCATION 9 FRONT ELEVATION

The wire and pipe need sealing.

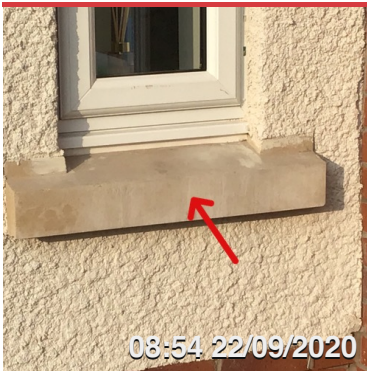
LOCATION 10 FRONT ELEVATION

The artstone cills and heads need the mortar staining removing.

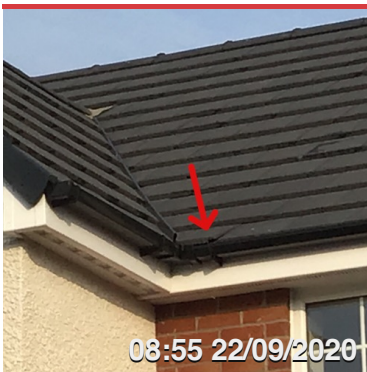
LOCATION 11 FRONT ELEVATION

The bottom tile on the right hand valley is kicking.

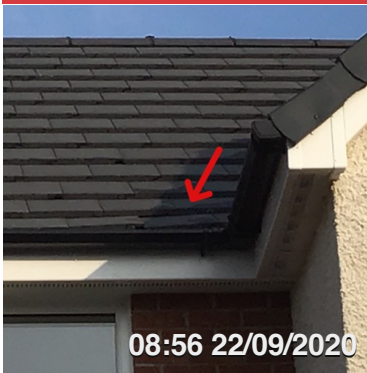
LOCATION 12 FRONT ELEVATION

The bottom tiles are kicking on the left hand valley.

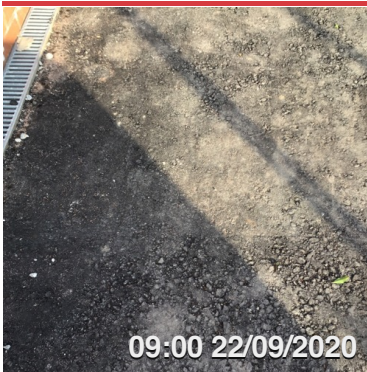
LOCATION 13 RIGHT HAND ELEVATION

The drive needs final surfacing, please supply a date.

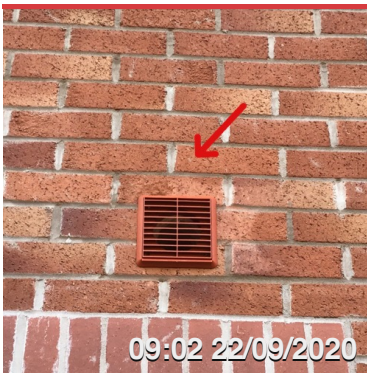
LOCATION 14 REAR ELEVATIO

The extractor duct needs a cavity tray installed above it.
NHBC Standards 6.1.17.

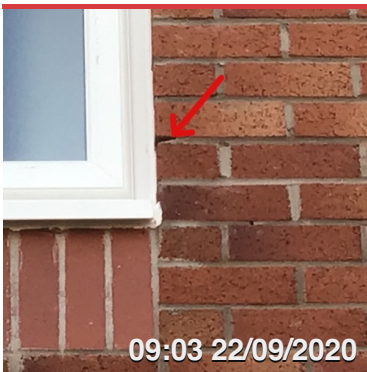
LOCATION 15 REAR ELEVATION

Several areas of pointing required on the rear elevation.

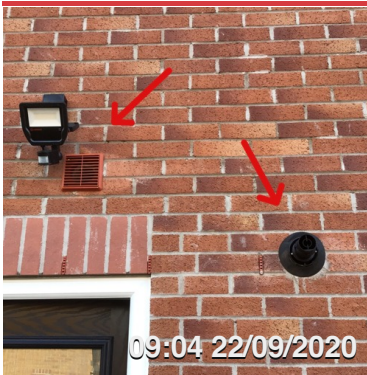
LOCATION 16 REAR ELEVATION

There are no cavity trays installed above the extractor a boiler flue ducts.

NHBC Standards 6.1.17

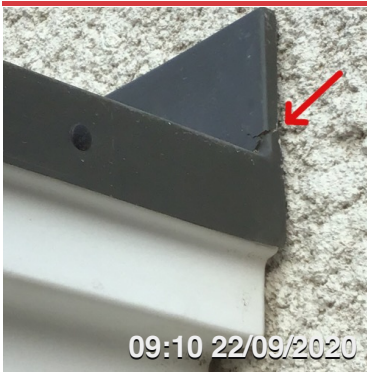
LOCATION 17 FRONT ELEVATION

The upstand on the canopy is damaged and needs repairing.

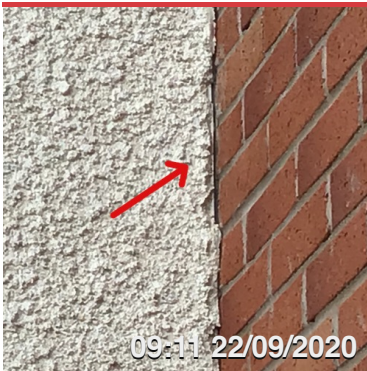
LOCATION 18 FRONT ELEVATION

The edges of the render where it meets the brickwork needs tidying.

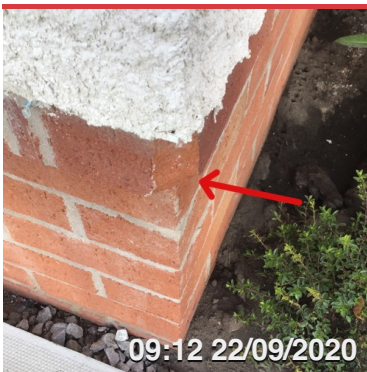
LOCATION 19 FRONT ELEVATION

The brick is damaged on the right hand corner below the render.

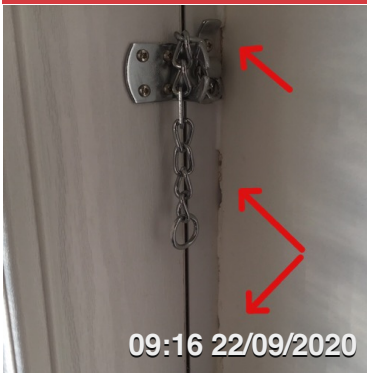
LOCATION 20 HALL

The frame needs caulking and behind the door chain.

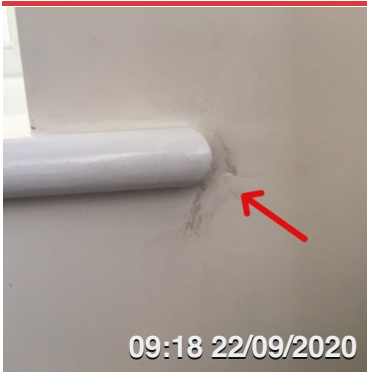
LOCATION 21 HALL

The wall needs sanding to the right of the window board.

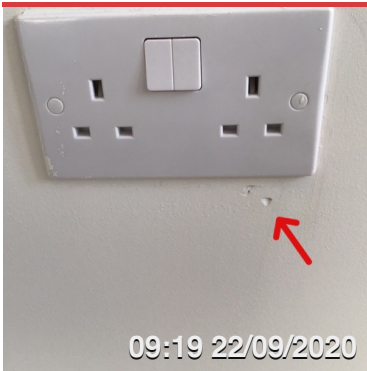
LOCATION 22 HALL

The wall needs filling underneath the double socket.

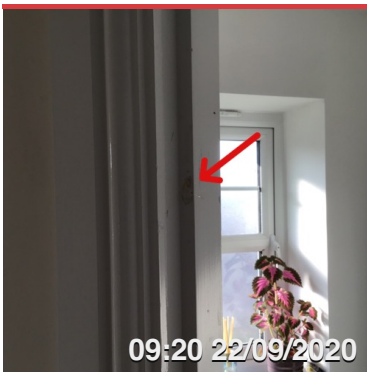
LOCATION 23 DOWNSTAIRS CLOAKS

The resin needs removing from the casing and door, and sealed before touching up.

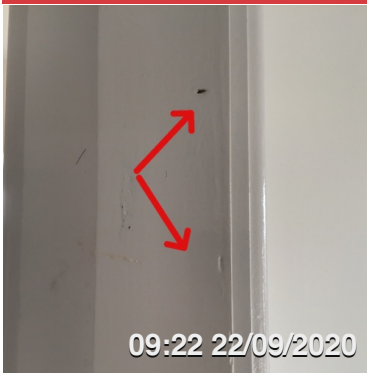
LOCATION 24 DOWNSTAIRS CLOAKS

The casing needs filling in several places.

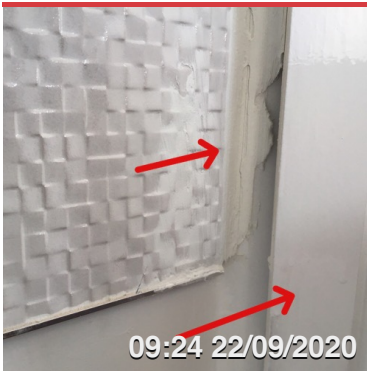
LOCATION 26 DOWNSTAIRS CLOAKS

The grout needs tidying and the architrave is grinning, the edge also needs painting.

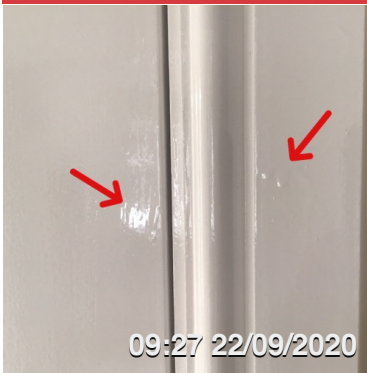
LOCATION 28 HALL

The paint runs need removing from the cloaks door and architrave.

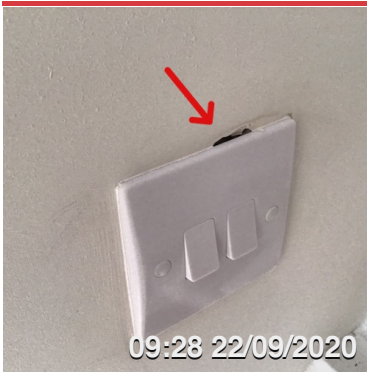
LOCATION 29 HALL

The wall needs filling above the light switch.

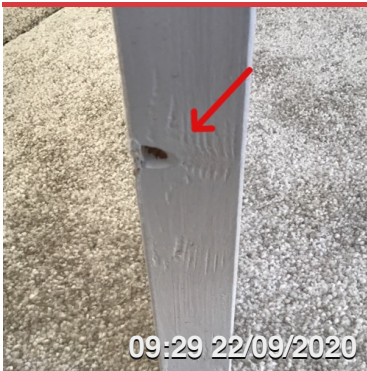
LOCATION 30 LOUNGE

The door edge needs filling.

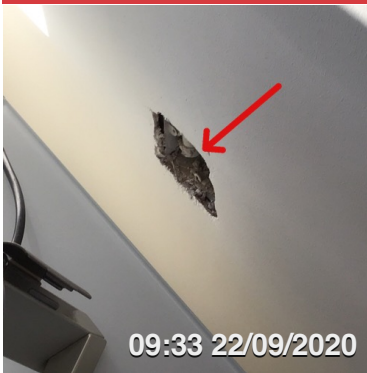
LOCATION 32 LOUNGE

The open gas point needs a cover plate fitting and patching.

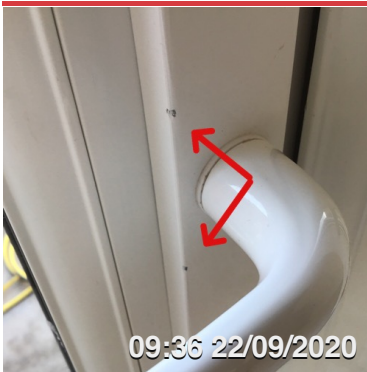
LOCATION 33 LOUNGE

The left hand patio door handle is damaged and needs replacing.

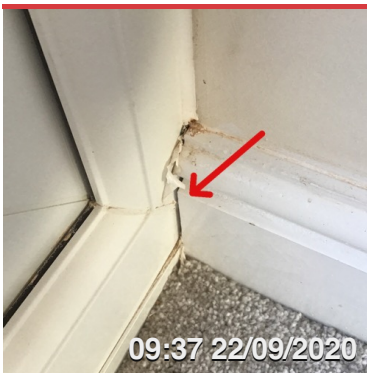
LOCATION 34 LOUNGE

The skirting board both sides of the patio doors need caulking.

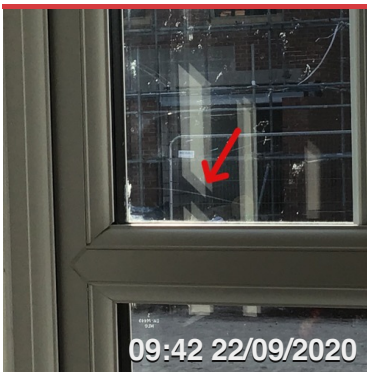
LOCATION 35 KITCHEN

The glass is scratched in the front window and visible from 2m.

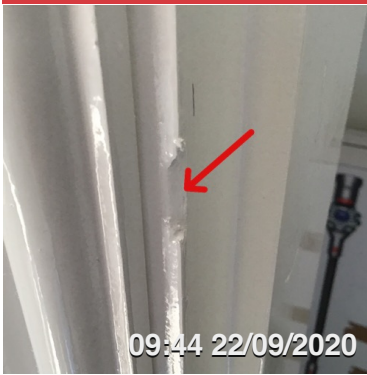
LOCATION 36 KITCHEN

The understairs cupboard casing needs filling in several places.

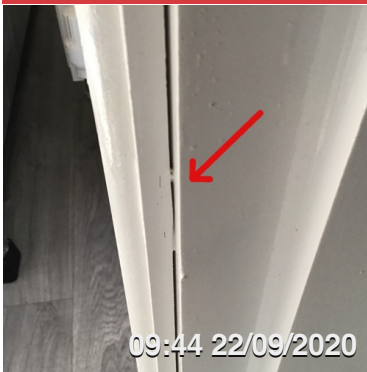
LOCATION 37 KITCHEN

The understairs cupboard architrave needs caulking.

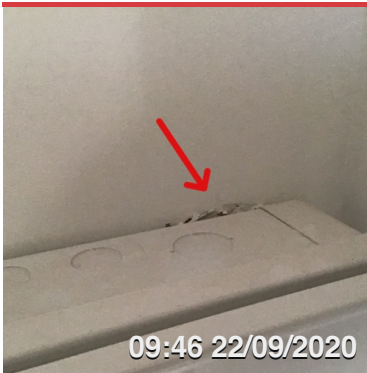
LOCATION 38 UNDERSTAIRS CUPBOARD

The wall needs filling behind the consumer unit.

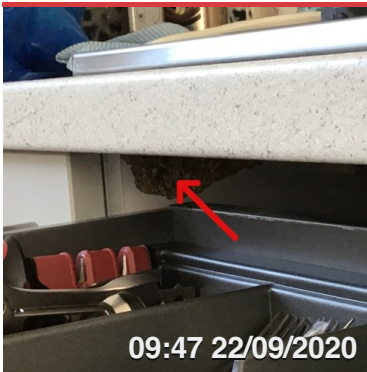
LOCATION 39 KITCHEN

Both end panels in the drawer unit have been damaged when the timber stretcher has been removed.

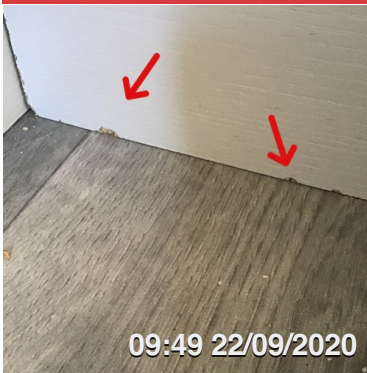
LOCATION 40 KITCHEN

The bottom of the plinth has been damaged underneath the freezer, and needs repairing.

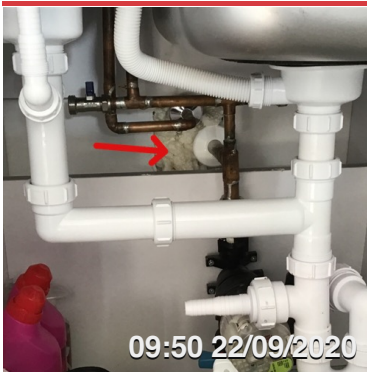
LOCATION 41 KITCHEN

The sink base needs a shelf fitting and the wall needs the expanding foam removing and patching.

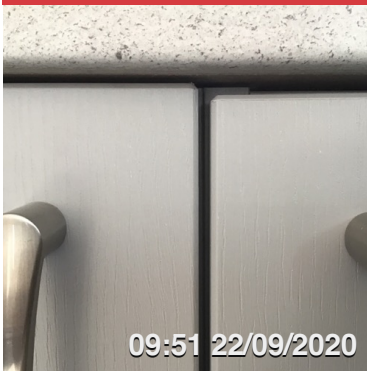
LOCATION 42 KITCHEN

The sink base unit doors need adjusting.

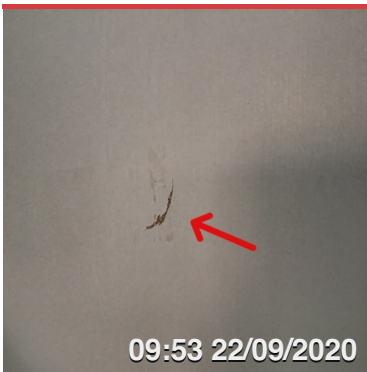
LOCATION 43 KITCHEN

The right hand wall unit end panel is damaged and needs.

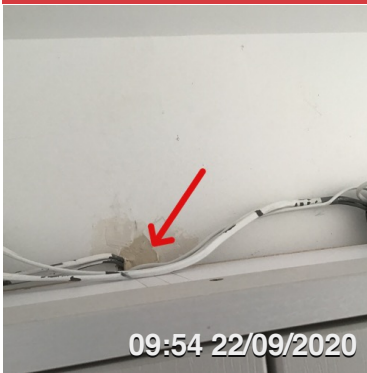
LOCATION 44 KITCHEN

The wall needs filling and touching up above the wall units and the cables need clipping down.

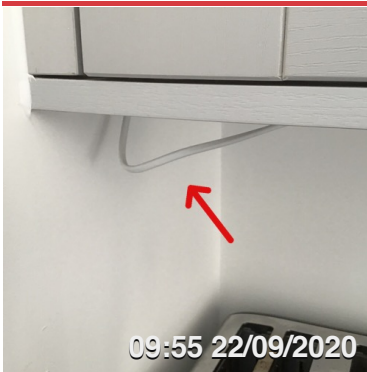
LOCATION 45 KITCHEN

The cable for the under pelmet lights needs lifting.

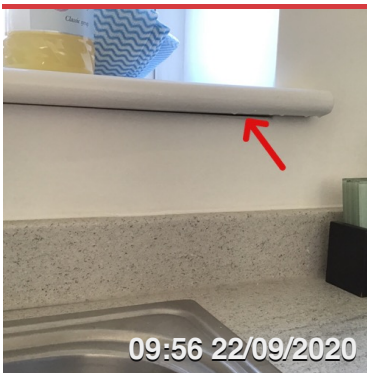
LOCATION 46 KITCHEN

The window board needs caulking underneath.

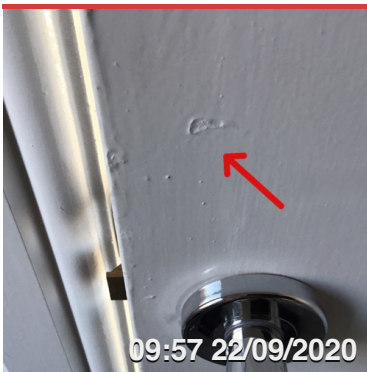
LOCATION 47 UTILITY

The door needs sanding above the handle.

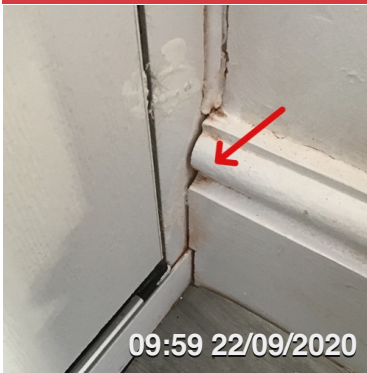
LOCATION 48 UTILITY

The skirting boards need caulking at the door casing.

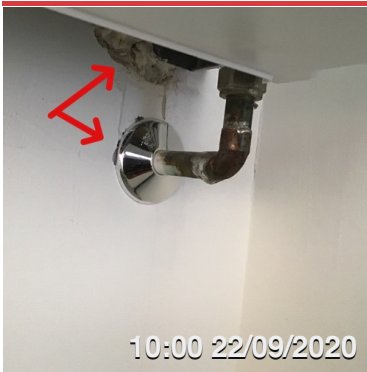
LOCATION 49 UTILITY

The wall needs filling around the pipes underneath the boiler.

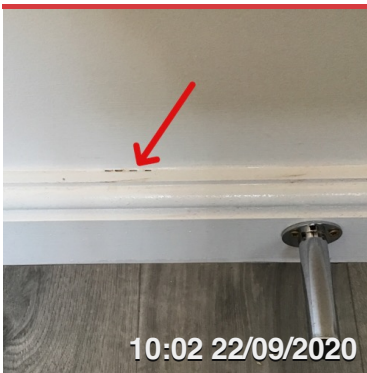
LOCATION 50 UTILITY

The top of the skirting board needs caulking.

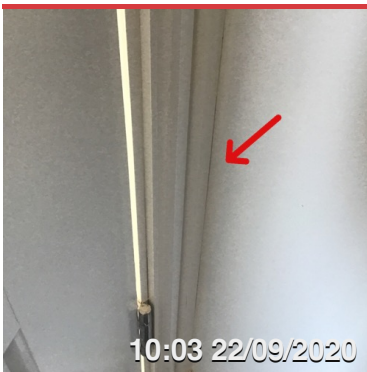
LOCATION 51 UTILITY

The quadrant needs caulking behind the door.

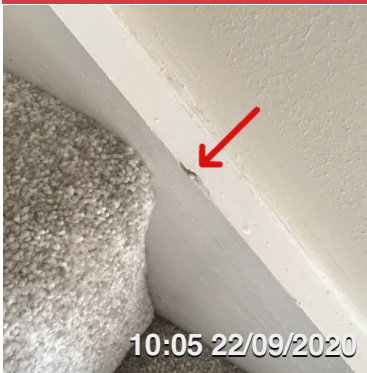
LOCATION 52 STAIRS TO FIRST FLOOR

The right hand string needs filling.

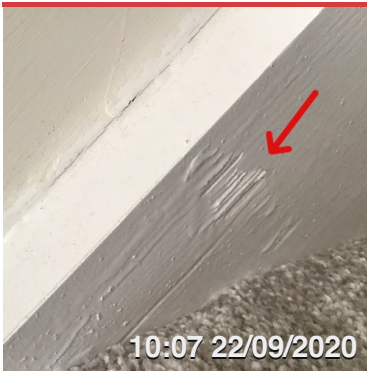
LOCATION 54 STAIRS TO FIRST FLOOR

The left hand string needs sanding.

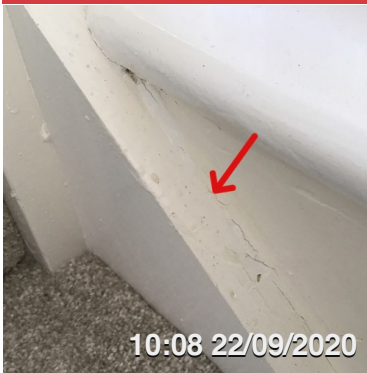
LOCATION 56 STAIRS TO FIRST FLOOR

The paint run at the top of the right hand string needs removing.

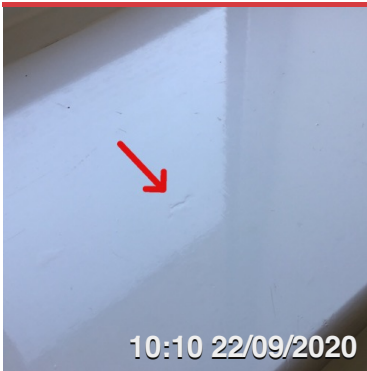
LOCATION 58 LANDING

The window board needs filling.

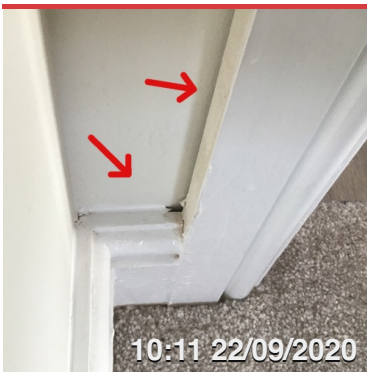
LOCATION 59 LANDING

The skirting needs caulking and the architrave edge needs painting to the bathroom door.

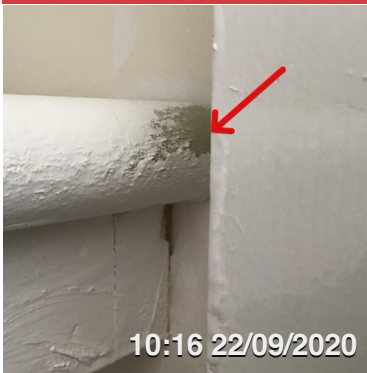
LOCATION 64 BEDROOM 2

The wardrobe shelf needs painting in places.

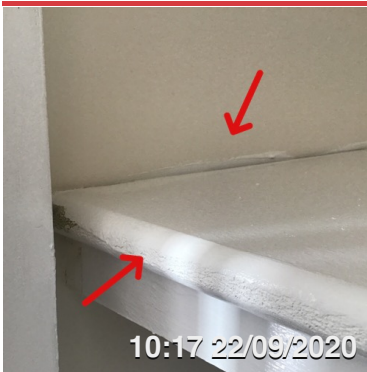
LOCATION 65 BEDROOM 2

The paint needs removing from the wall and the edge of the wardrobe shelf needs sanding.

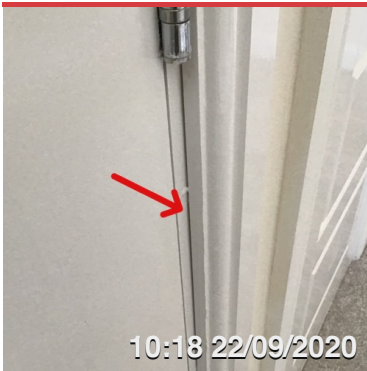
LOCATION 66 BEDROOM 2

The wardrobe architraves need caulking.

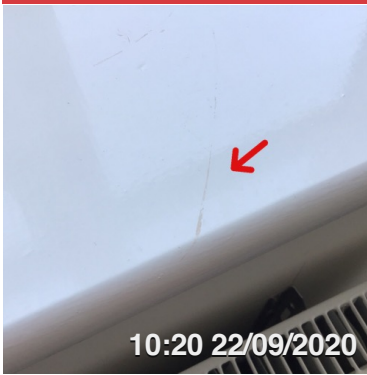
LOCATION 68 BEDROOM 2

The window board is marked and needs touching up.

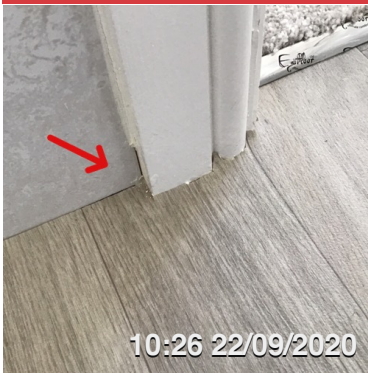
LOCATION 72 BATHROOM

The bottom of the tile needs grouting.

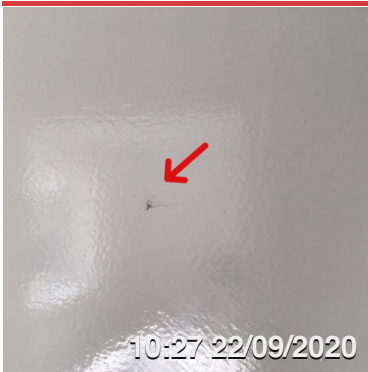
LOCATION 73 CYLINDER CUPBOARD

The front of the door is marked and needs touching up.

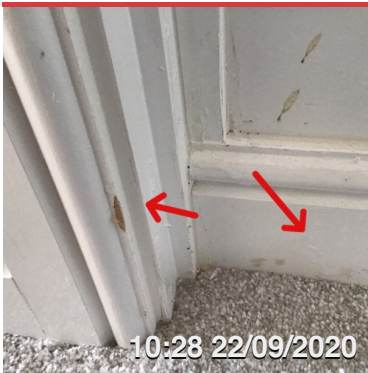
LOCATION 74 CYLINDER CUPBOARD

The architrave is damaged and needs filling and the skirting board needs redecorating.

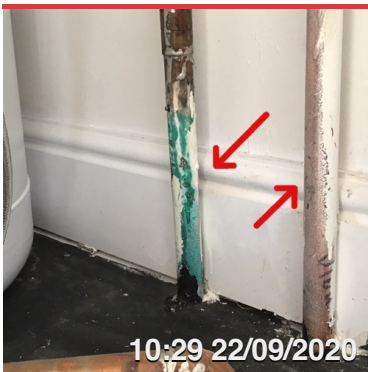
LOCATION 75 CYLINDER CUPBOARD

The flux needs removing from the pipe, and either removing the paint from the other pipe or paint them.

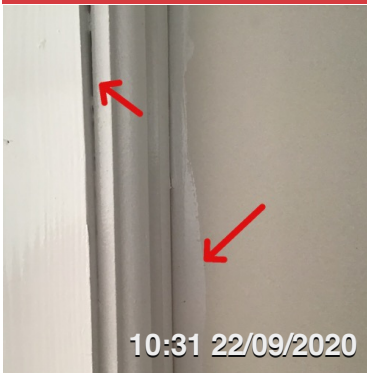
LOCATION 76 CYLINDER CUPBOARD

The gloss needs painting over and the architrave needs caulking.

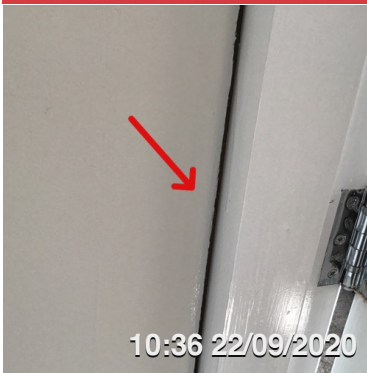
LOCATION 80 BEDROOM 1

The wardrobe casing needs a quadrant or bead fitting.

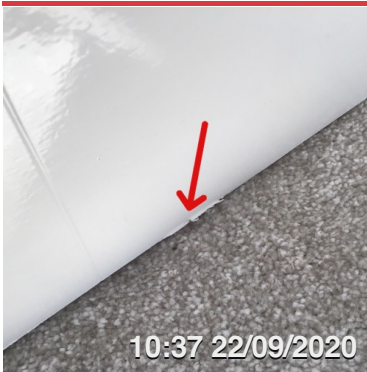
LOCATION 81 BEDROOM 1

The bottom of the wardrobe doors needs sanding.

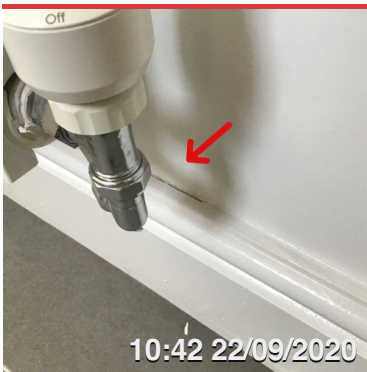
LOCATION 83 EN SUITE

The skirting board behind the radiator needs caulking.

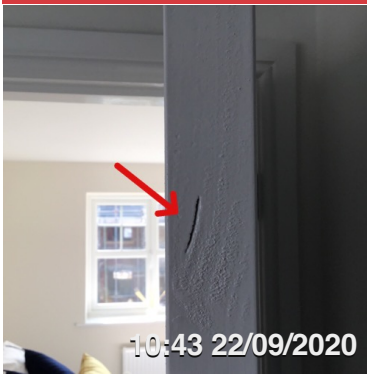
LOCATION 84 EN SUITE

The door edge needs filling.

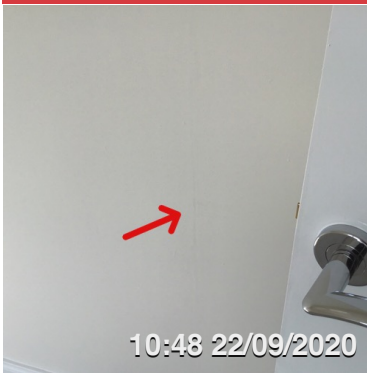
LOCATION 88 BEDROOM 3

The wall needs fine filling.

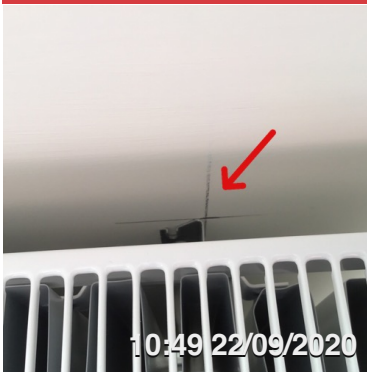
LOCATION 89 BEDROOM 3

The pencil lines need removing from behind the radiator.

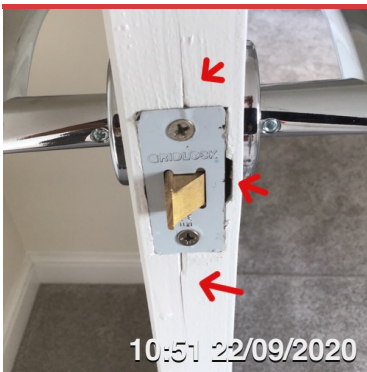
LOCATION 91 BEDROOM 3

The door edge needs filling around the latch.

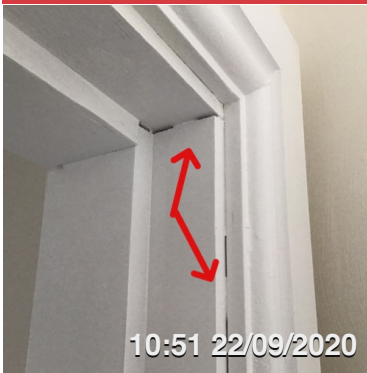
LOCATION 92 BEDROOM 3

The casing and architrave need caulking.

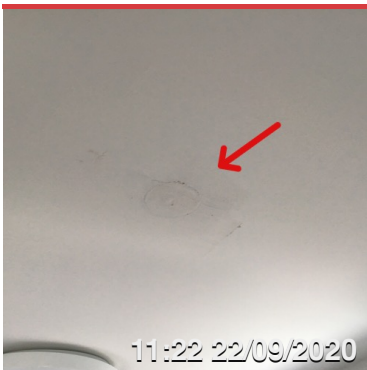
LOCATION 95 EN SUITE

The ceiling needs sanding and filling where it has previously been patched.
