# LYNTONVALE AVENUE GATLEY

Snagging Report

Thursday, 9 January 2020

Prepared For Mr N Jones

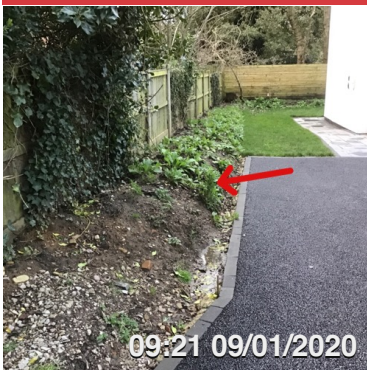
## **LOCATION 2 FRONT DRIVE**

The left hand garden area needs the rubble removing and the soil lowering to the drive edging.

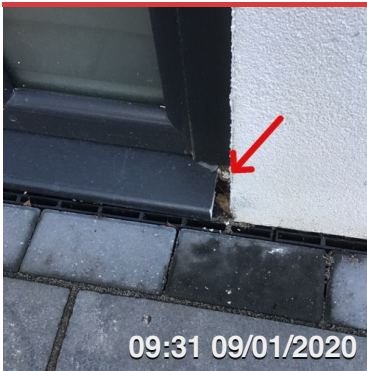
### LOCATION 10 FRONT ELEVATION

The front door threshold needs sealing to prevent water ingress.

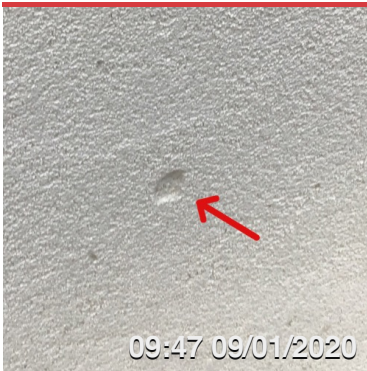
### **LOCATION 21 LEFT HAND ELEVATION**

Several areas along the render bead needs filling.

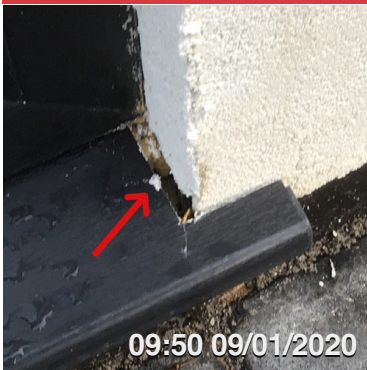
### LOCATION 24 REAR ELEVATION

The right hand corner bead needs filling at the bottom.

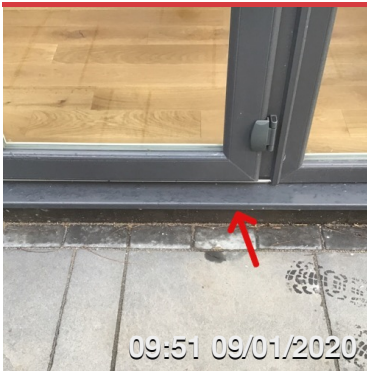
### LOCATION 25 REAR ELEVATION

The rear patio door cill has been cut short and needs replacing.

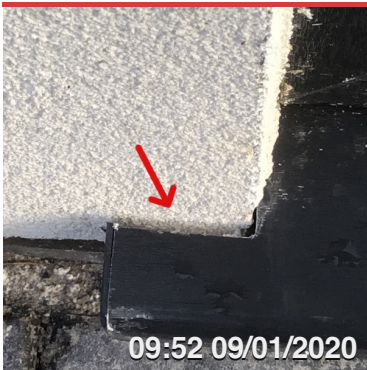
### LOCATION 26 REAR ELEVATION

The patio door cill needs sealing underneath to prevent water ingress.

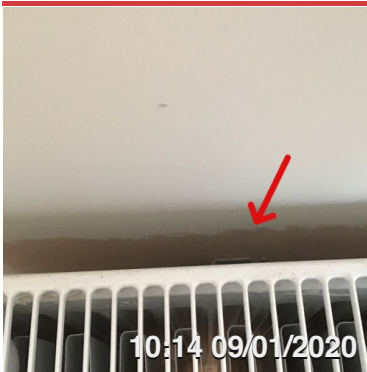
### **LOCATION 40 HALL**

The radiator pipes need patching and painting.

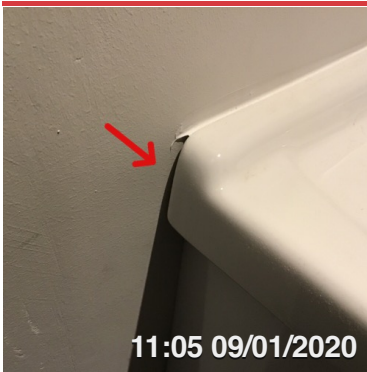
### **LOCATION 80 CYLINDER CUPBOARD**

The ceiling needs sealing with intumescent sealant around the edges.

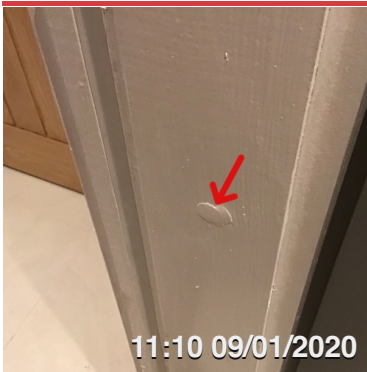
The architraves need caulking.

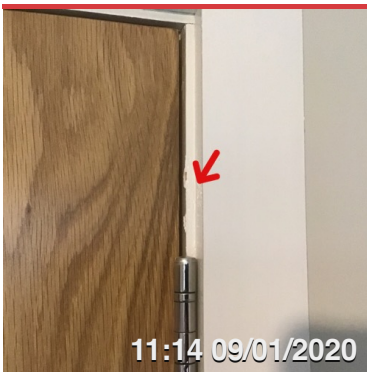
The floor is out of level and shows on the bottom of the door.

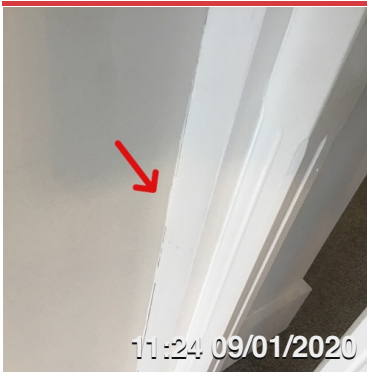
The cover bead needs caulking on the string.

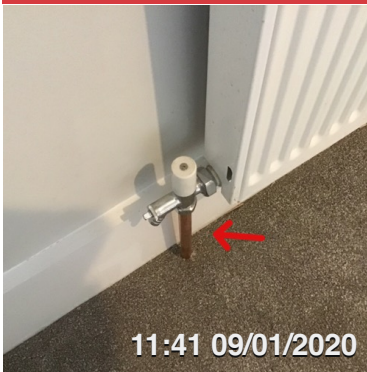
#### **LOCATION 112 BEDROOM 4**

All skirting board corners need caulking.

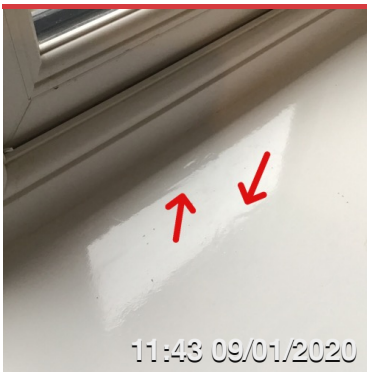
#### **LOCATION 114 BEDROOM 4**

The window frame and cill needs caulking.

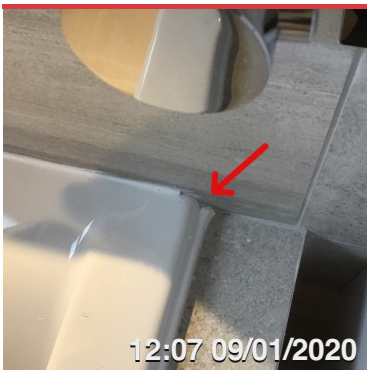
### **LOCATION 138 BATHROOM**

The tiles and tile trim need grouting to the front of the bath.
