I Lively
Lively Professional Services Ltd

**14 ATHERTON DRIVE, PRESCOT,
MERSEYSIDE, L35 7AG**

Monday, 25 March 2019

94 Issues Identified

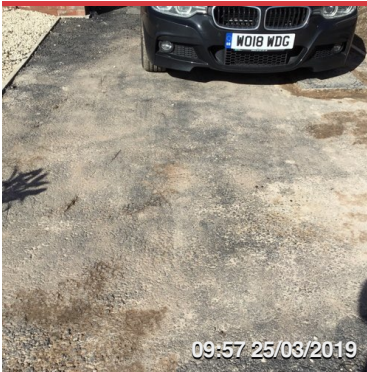
LOCATION 2 FRONT ELEVATION

The drive needs topping.

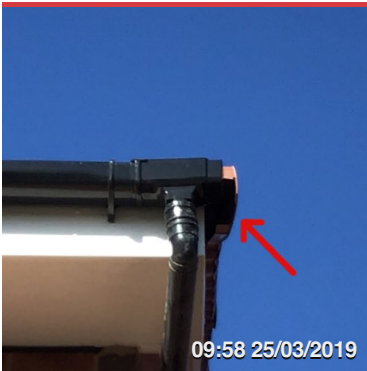
LOCATION 3 FRONT ELEVATION

The first dry verge needs a mechanical fixing and the gutter extending to the end of the dry verge to stop it dripping when it rains.

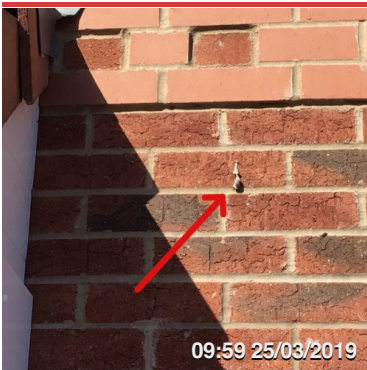
LOCATION 4 FRONT ELEVATION

Remove the excess lead sealant from the brickwork to the right of the canopy.

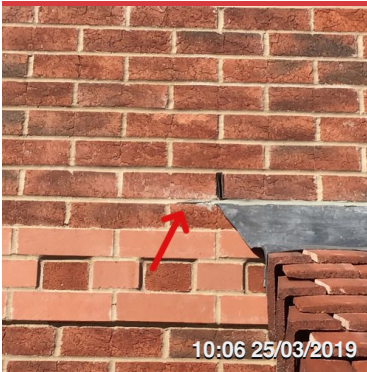
LOCATION 10 FRONT ELEVATION

The mortar joint needs pointing where it has been ground out.

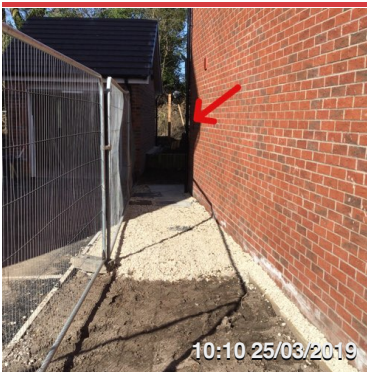
LOCATION 12 LEFT HAND ELEVATION

The fencing needs finishing, and the blow off sealing. The fencer was working on the fence during the inspection.

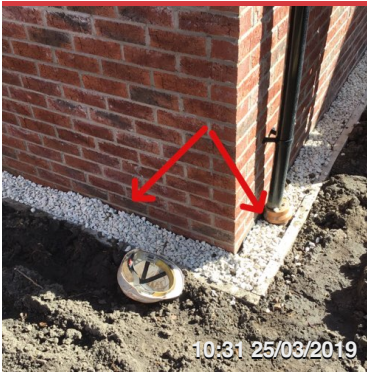
LOCATION 26 GARAGE

The tanking needs extending or the chippings lowering slightly, the tanking does not appear to be sealed against the brickwork which will let water ingress.

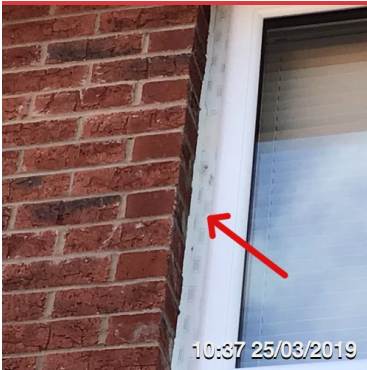
LOCATION 30 REAR ELEVATION

Remove the plastic protection from the window.

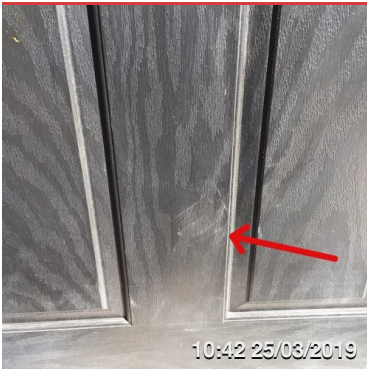
LOCATION 31 FRONT DOOR

The front door is scratched in numerous places.

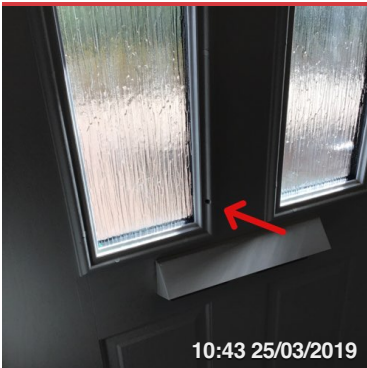
LOCATION 32 HALL

Button missing from the door glazing bead.

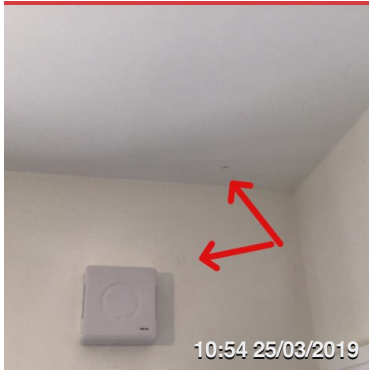
LOCATION 38 HALL

Nail pop and touch up around the bell box.

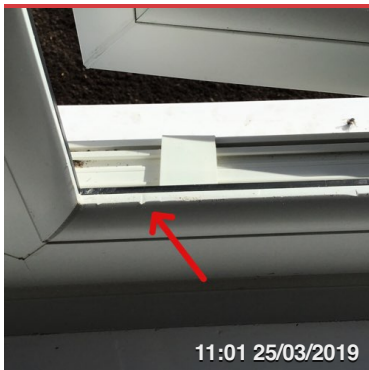
LOCATION 40 LOUNGE

The right hand opening window frame is damaged where materials have been brought in through the window.

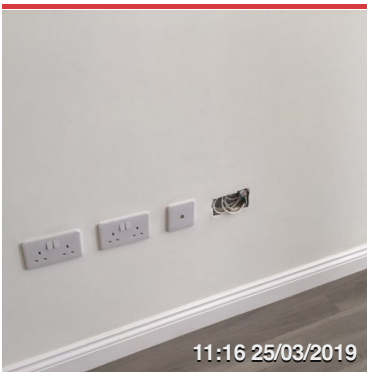
LOCATION 44 LOUNGE

The plate front needs fitting to the fibre cables.

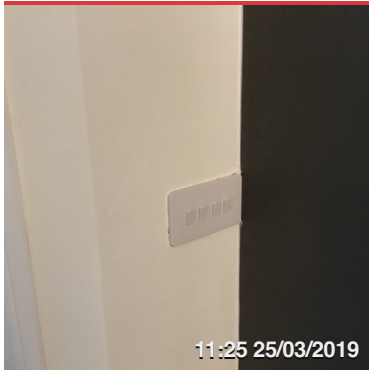
LOCATION 46 KITCHEN

Fill and touch up around the light switch.

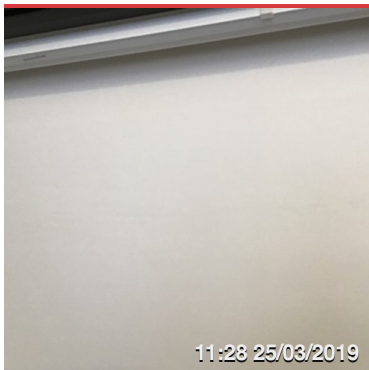
LOCATION 48 KITCHEN

The utility area ceiling needs filling, poor plastering.

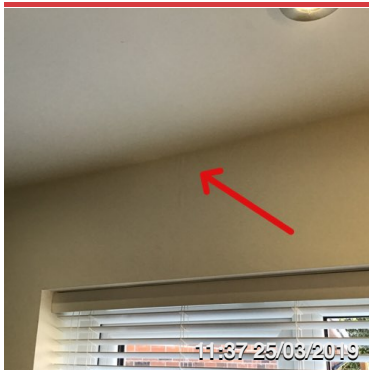
LOCATION 52 KITCHEN

The wall above the window needs sanding.

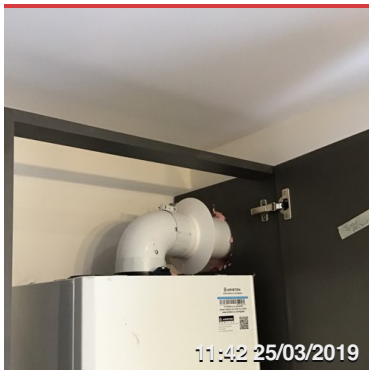
LOCATION 56 KITCHEN

The shroud needs fitting to the flue.

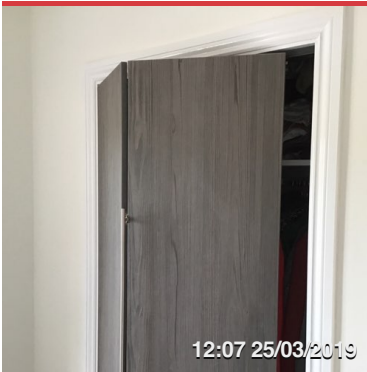
LOCATION 74 BEDROOM 2

The wardrobe door is difficult to close with the handle when fully opened.

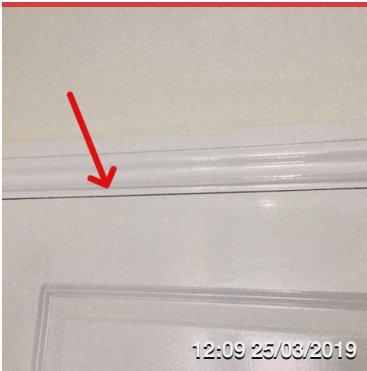
LOCATION 75 BATHROOM

The top of the door edge is rough.

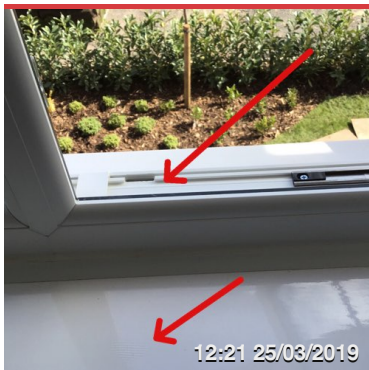
LOCATION 84 BEDROOM 1

The right hand window opening frame is damaged, and the window sill needs attention.
