I Lively (Former CEnv FCIOB MCABE)
Lively Professional Services Ltd

37 STAUNTON DRIVE CARLISLE CUMBRIA CA1 3GU

Snagging Report

Friday, 14 August 2020

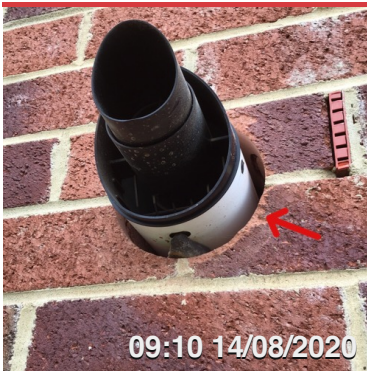
LOCATION 10 LEFT HAND ELEVATION

The stone packer underneath the gas flue needs removing and the flue needs sealing.

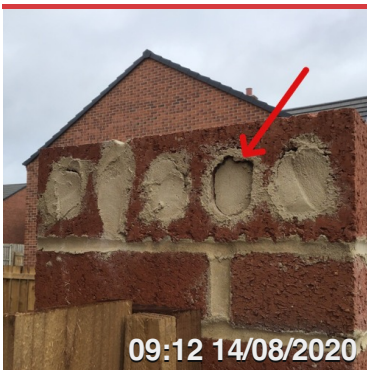
LOCATION 11 REAR GARDEN WALL

The holes in the brick need fully filling or replacing with solid brick.

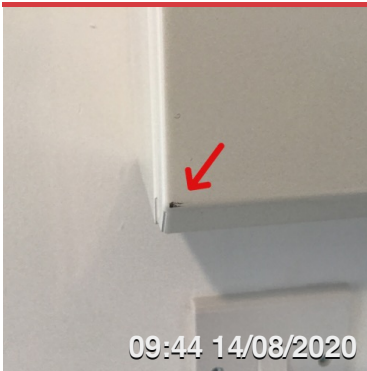
LOCATION 30 HALL

The corner of the consumer unit is damaged and needs repairing.

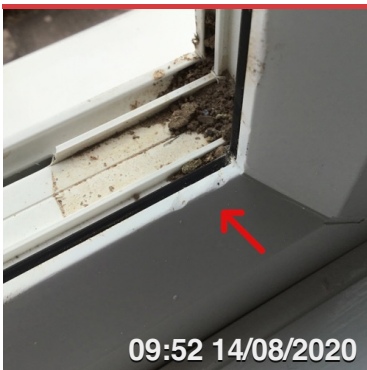
LOCATION 35 LOUNGE

The top edge of the window opening sash has been damaged when materials have been brought through it, and needs repairing.

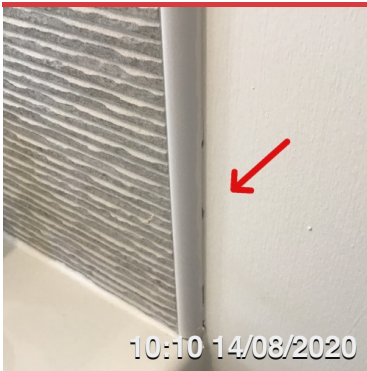
LOCATION 46 DOWNSTAIRS CLOAKS

The edge of the tile trim needs caulking.

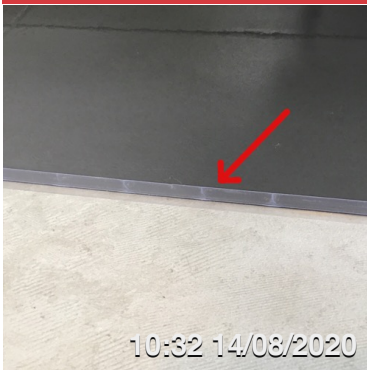
LOCATION 61 KITCHEN

The plastic trim on the bottom of the plinths is damaged in several places and needs replacing.

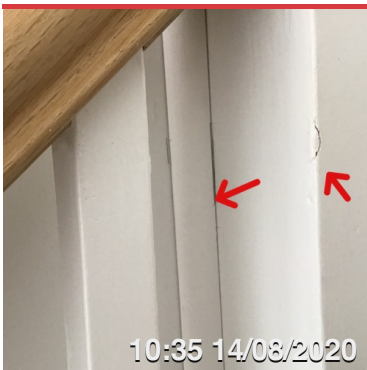
LOCATION 63 STAIRS TO FIRST FLOOR

He quadrant needs caulking and the newel needs filling where it has been damaged.

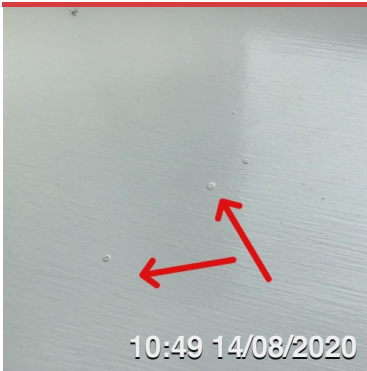
LOCATION 74 BEDROOM 3

The paint drips need removing from the window board.

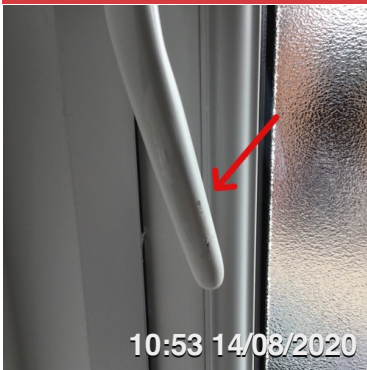
LOCATION 77 BATHROOM

The bathroom window handle is damaged and needs replacing.
