I Lively (Former CEnv FCIOB MCABE)
Lively Professional Services Ltd

93 ST KEVINS DRIVE KIRKBY LIVERPOOL L32 1BB

Snagging Report

Tuesday, 22 September 2020

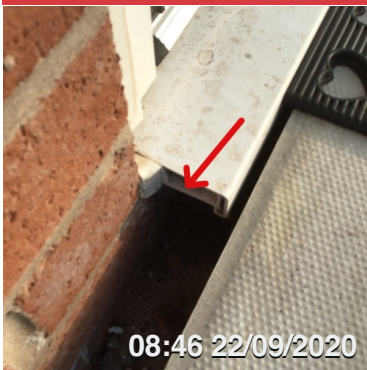
LOCATION 3 FRONT ELEVATION

Assigned To Joiner
The front door cill needs an end cap fitting.

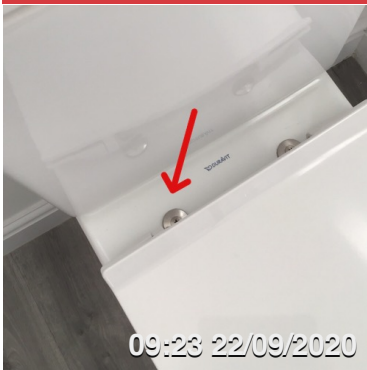
LOCATION 25 DOWNSTAIRS CLOAKS

The toilet seat is loose.

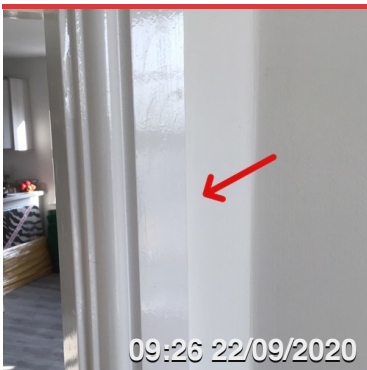
LOCATION 27 DOWNSTAIRS CLOAKS

The architraves need caulking.

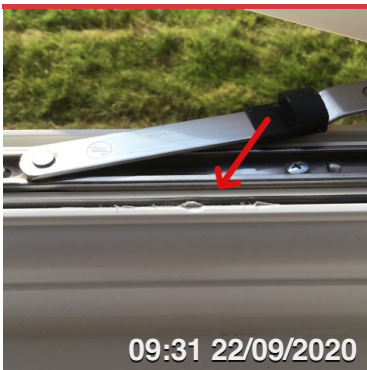
LOCATION 31 LOUNGE

The top edge of the front window frame is damaged where materials have been brought through it.

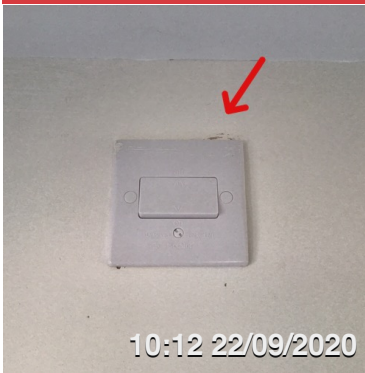
LOCATION 60 LANDING

The wall needs touching up around the isolator switch.

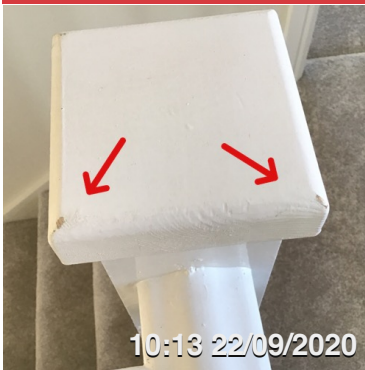
LOCATION 61 LANDING

The top of the newel cap needs touching up.

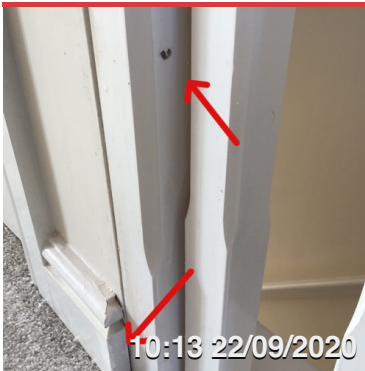
LOCATION 62 LANDING

The hole in the half newel needs filling and the skirting board needs painting.

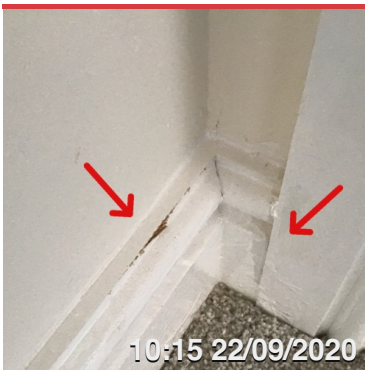
LOCATION 63 BEDROOM 2

The skirting is damaged and needs filling and touching up

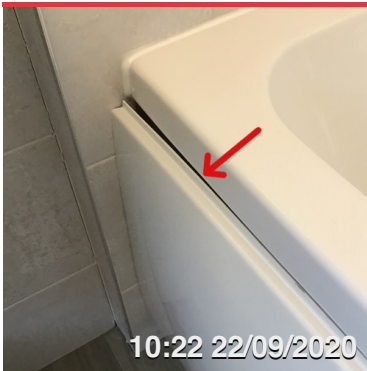
LOCATION 70 BATHROOM

The bath panel needs fitting properly.

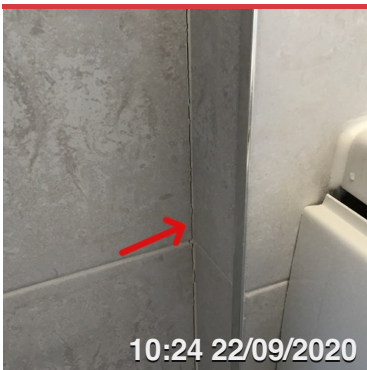
LOCATION 71 BATHROOM

The grout has cracked and needs a bead of sealant as this will continue to crack.

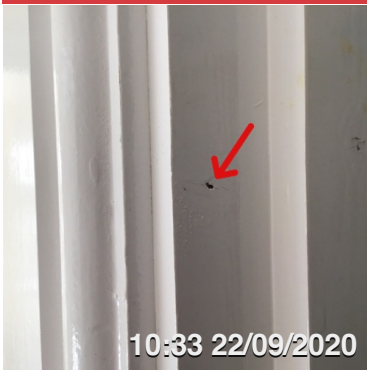
LOCATION 77 CYLINDER CUPBOARD

The casing needs filling in several places and repainting.

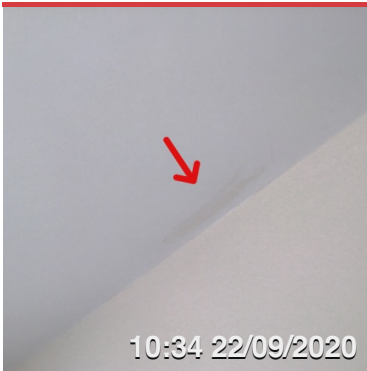
LOCATION 78 BEDROOM 1

The ceiling needs touching up above the bed.

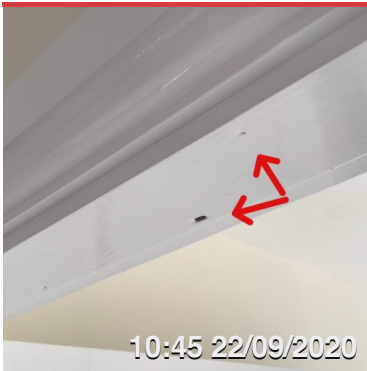
LOCATION 86 BEDR4

The casing needs filling in several places.

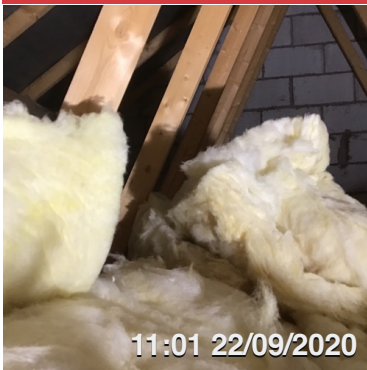
LOCATION 93 ROOF SPACE

The insulation needs tidying.

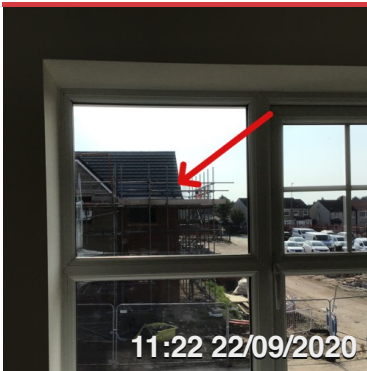
LOCATION 94 BEDROOM 3

The bars are missing in the glazing unit.
